Suite 3603

July 3rd, 2012

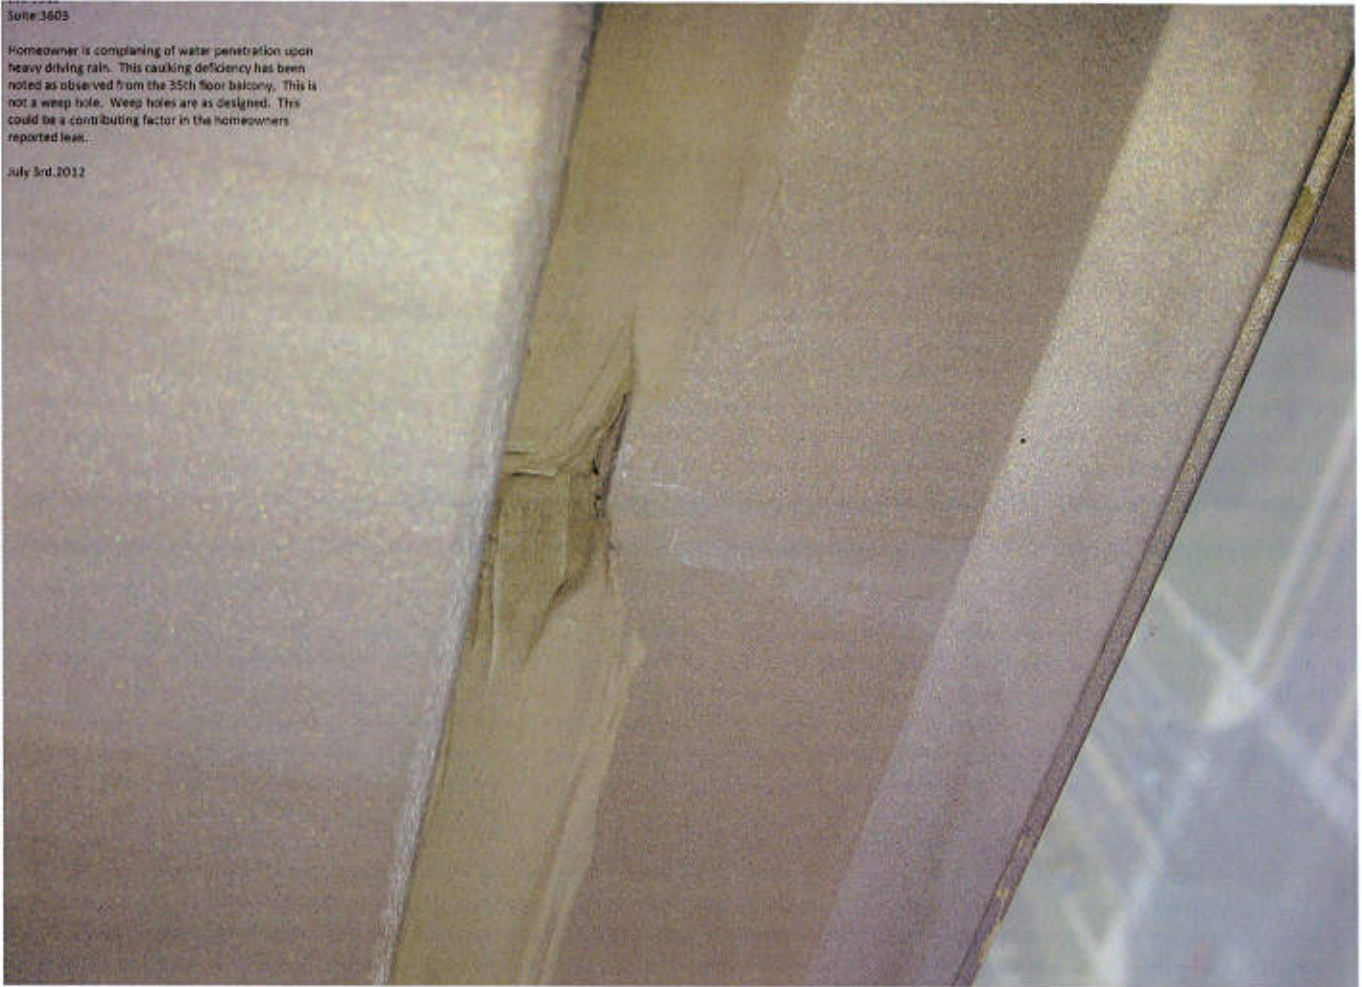
Homeowner is complaining of water penetration upon heavy driving rain. This caulking deficiency has been noted as observed from the 35th floor balcony. This is not a weep hole. Weep holes are as designed. This could be a contributing factor in the homeowners reported leak.

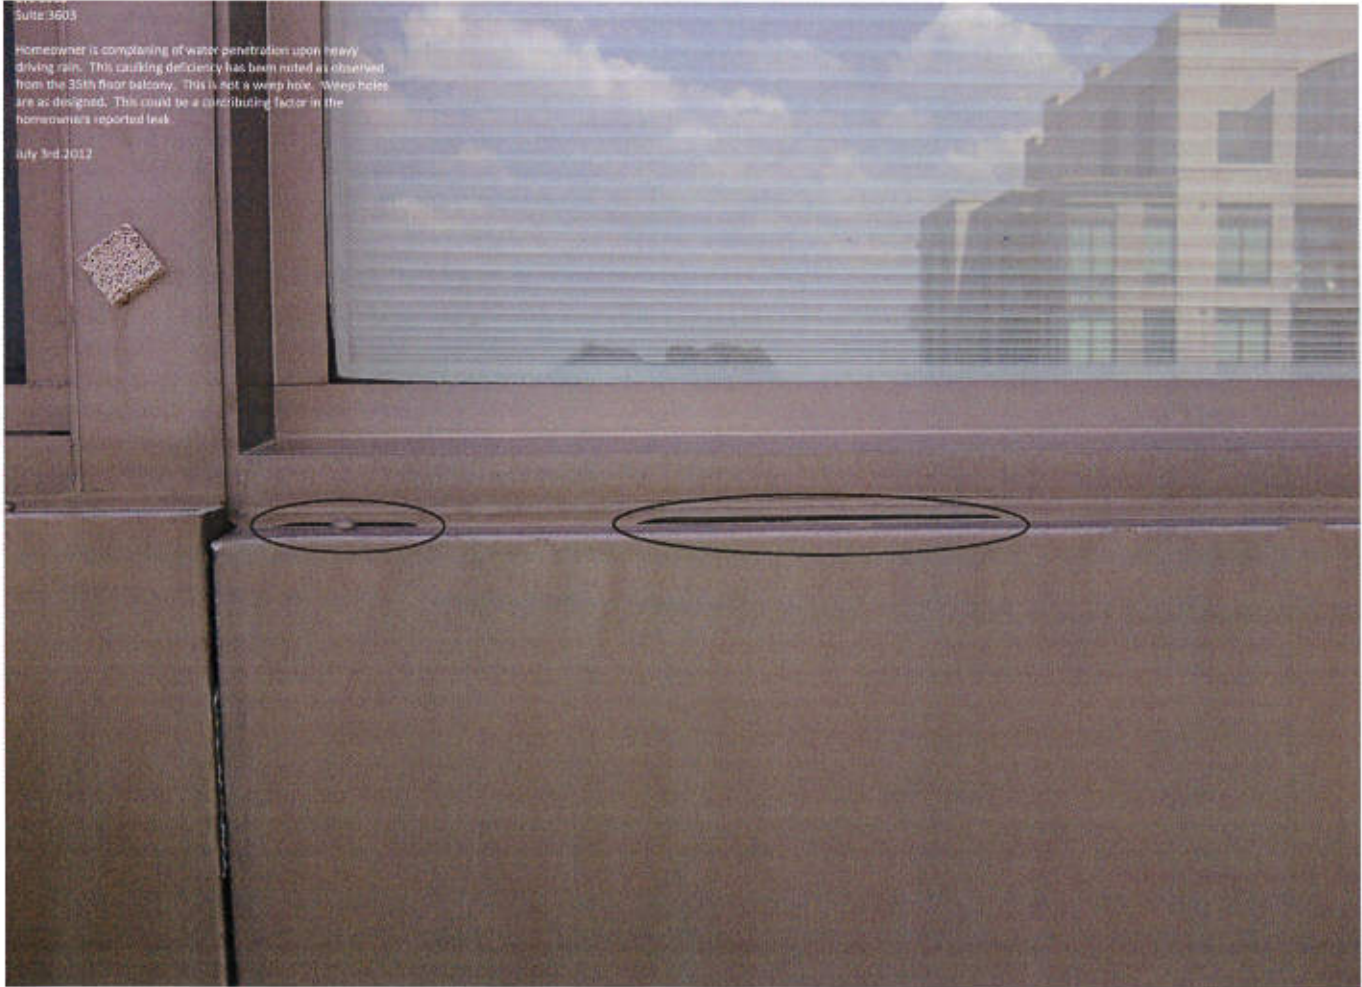
Suite 3603

Homeowner is complaining of water penetration upon heavy driving rain. This caulking deficiency has been noted as observed from the 35th floor balcony. This is not a weep hole. Weep holes are as designed. This could be a contributing factor in the homeowners reported leak.

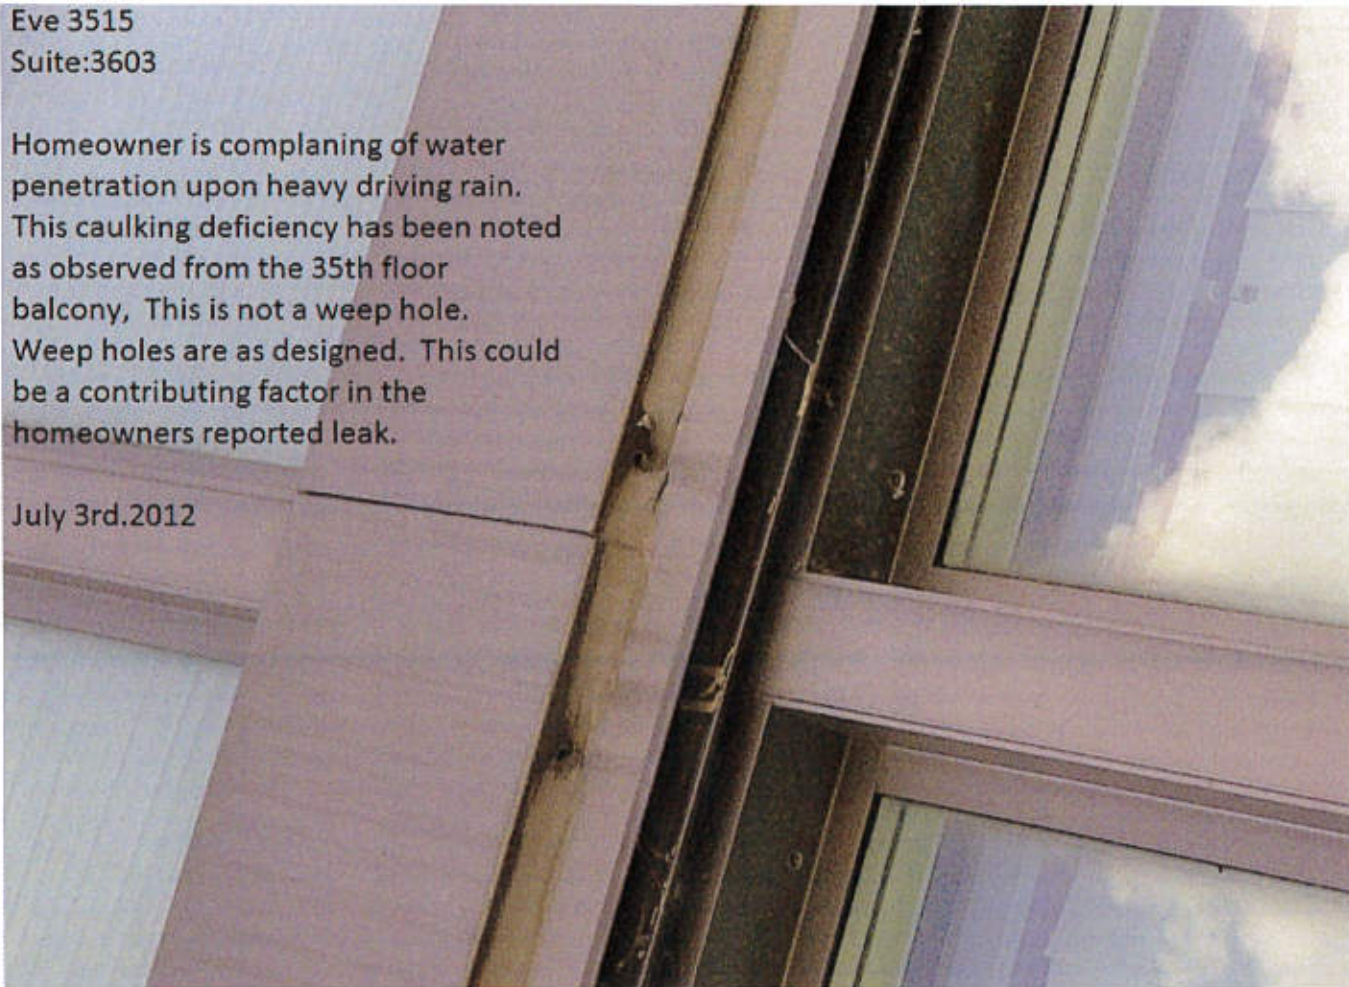
Eve 3515
Suite:3603

Homeowner is complaining of water penetration upon heavy driving rain. This caulking deficiency has been noted as observed from the 35th floor balcony, This is not a weep hole. Weep holes are as designed. This could be a contributing factor in the homeowners reported leak.

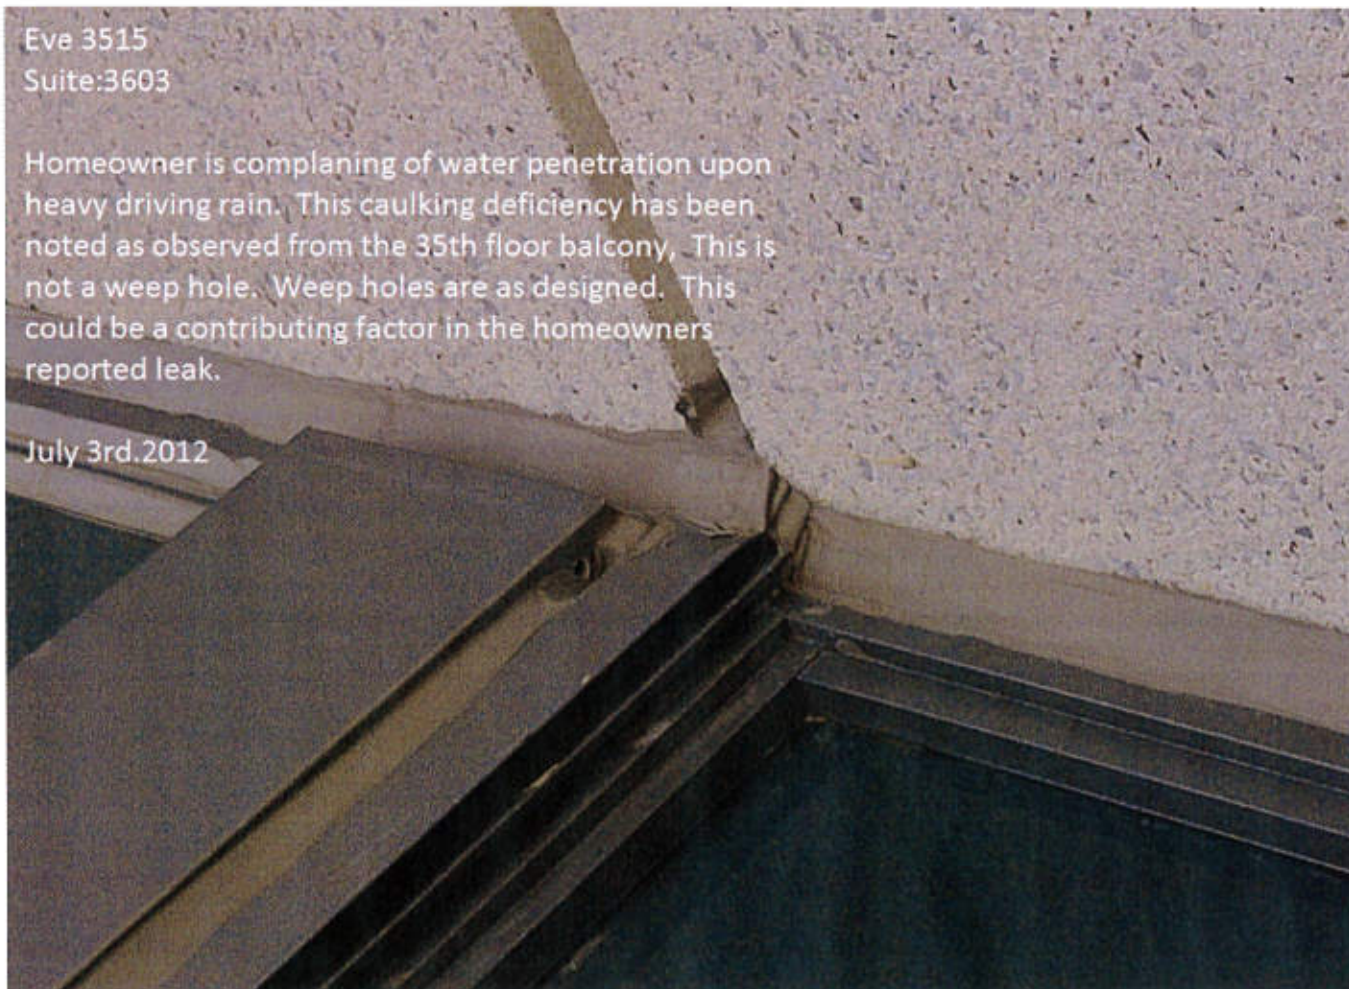
Eve 3515
Suite:3603

Homeowner is complaining of water penetration upon heavy driving rain. This caulking deficiency has been noted as observed from the 35th floor balcony, This is not a weep hole. Weep holes are as designed. This could be a contributing factor in the homeowners reported leak.

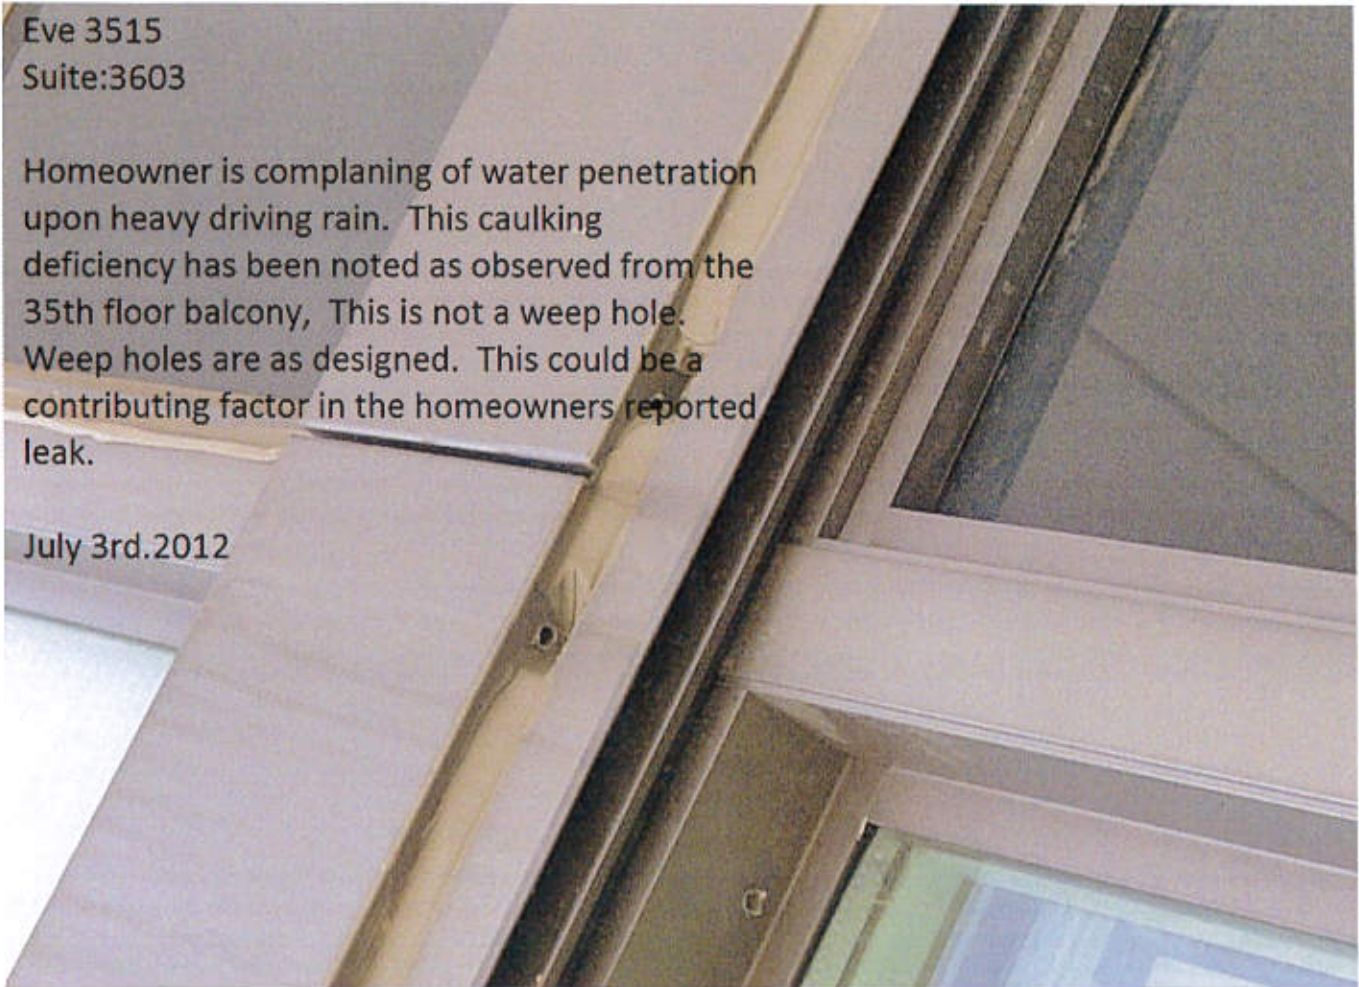
Eve 3515
Suite:3603

Homeowner is complaining of water penetration upon heavy driving rain. This caulking deficiency has been noted as observed from the 35th floor balcony, This is not a weep hole. Weep holes are as designed. This could be a contributing factor in the homeowners reported leak.

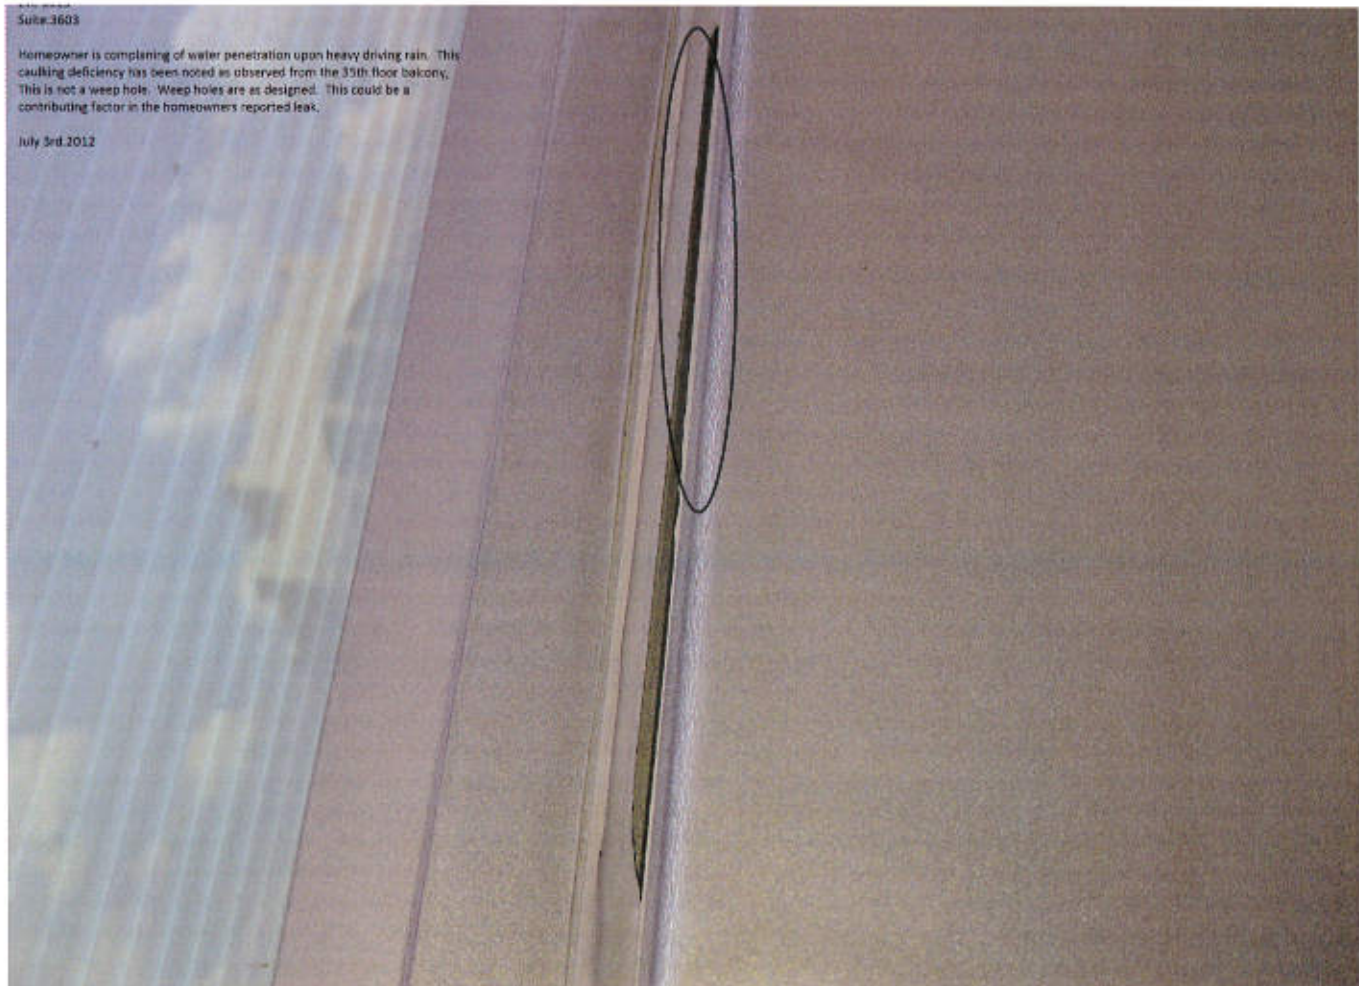
Eve 3515
Suite:3603

Homeowner is complaining of water penetration upon heavy driving rain. This caulking deficiency has been noted as observed from the 35th floor balcony. This is not a weep hole. Weep holes are as designed. This could be a contributing factor in the homeowners reported leak.

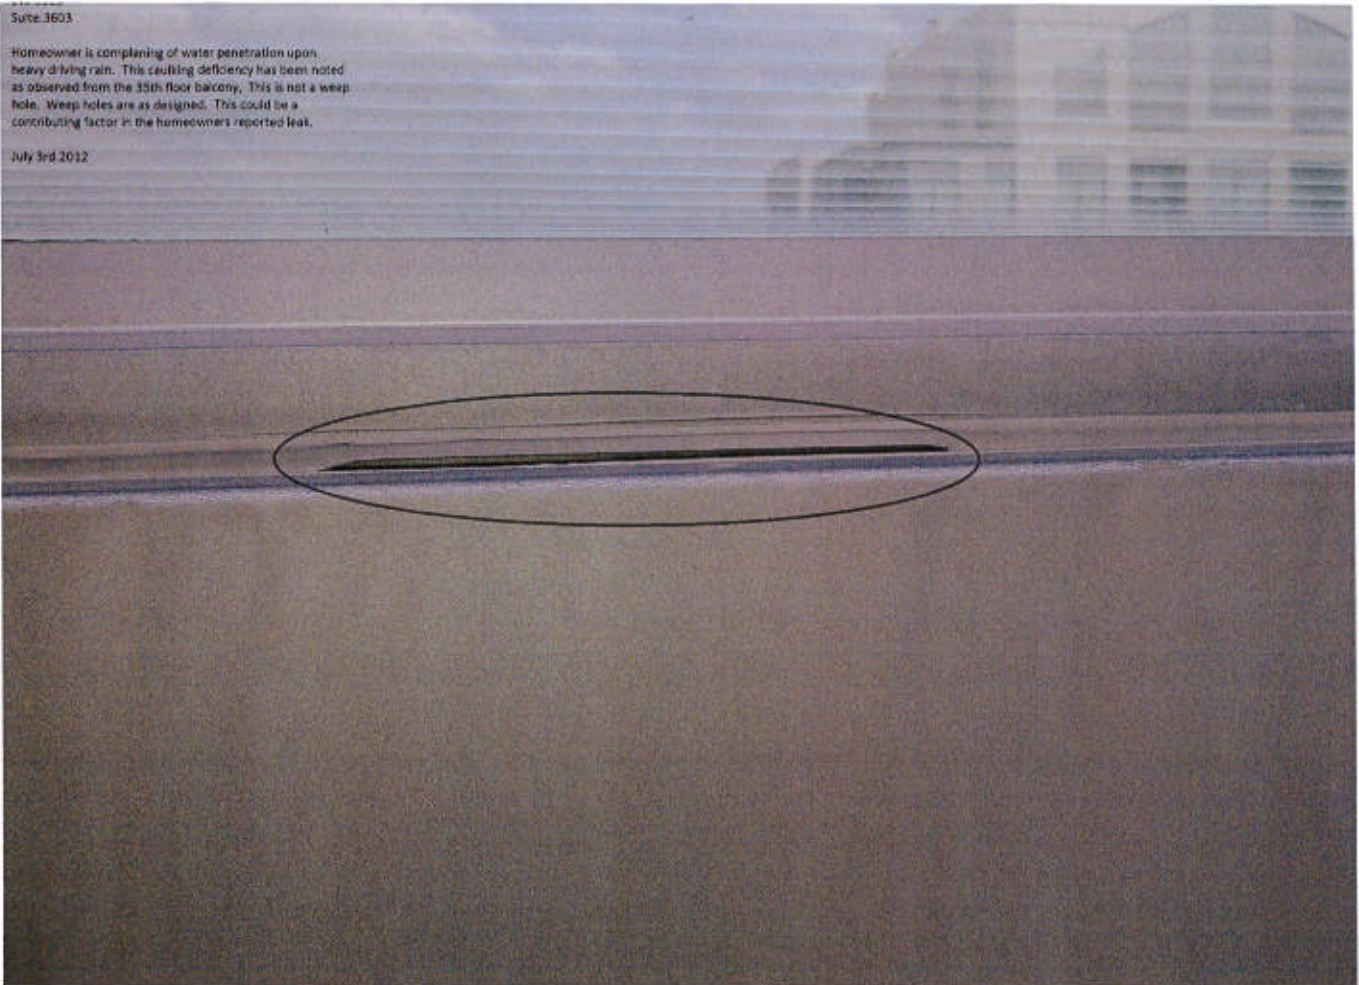
Suite 3603

Homeowner is complaining of water penetration upon heavy driving rain. This caulking deficiency has been noted as observed from the 35th floor balcony. This is not a weep hole. Weep holes are as designed. This could be a contributing factor in the homeowners reported leak.

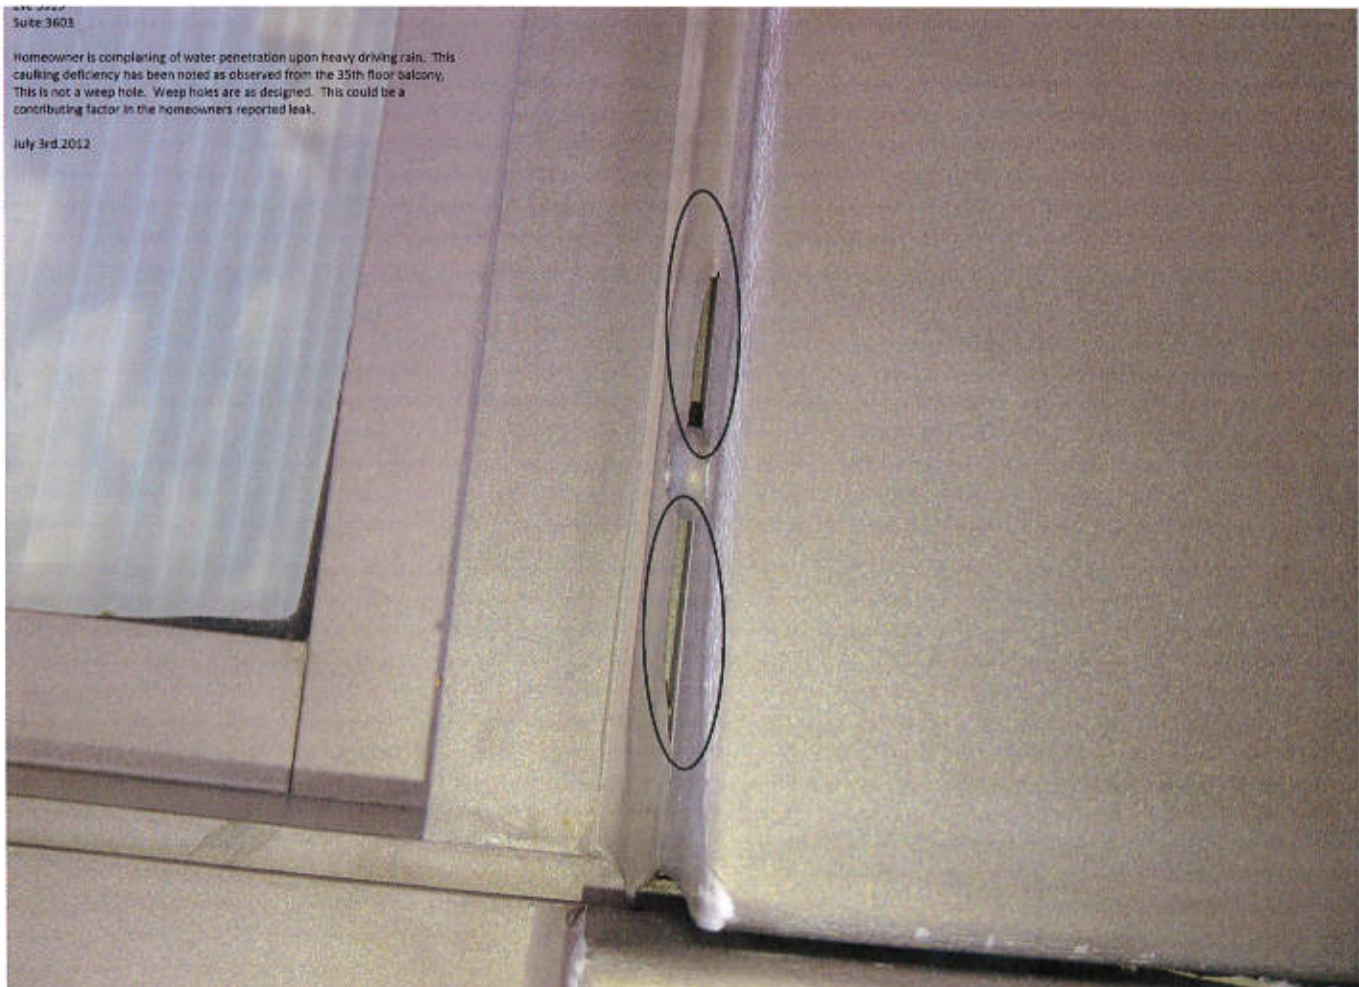
Suite 3603

Homeowner is complaining of water penetration upon heavy driving rain. This caulking deficiency has been noted as observed from the 35th floor balcony. This is not a weep hole. Weep holes are as designed. This could be a contributing factor in the homeowners reported leak.

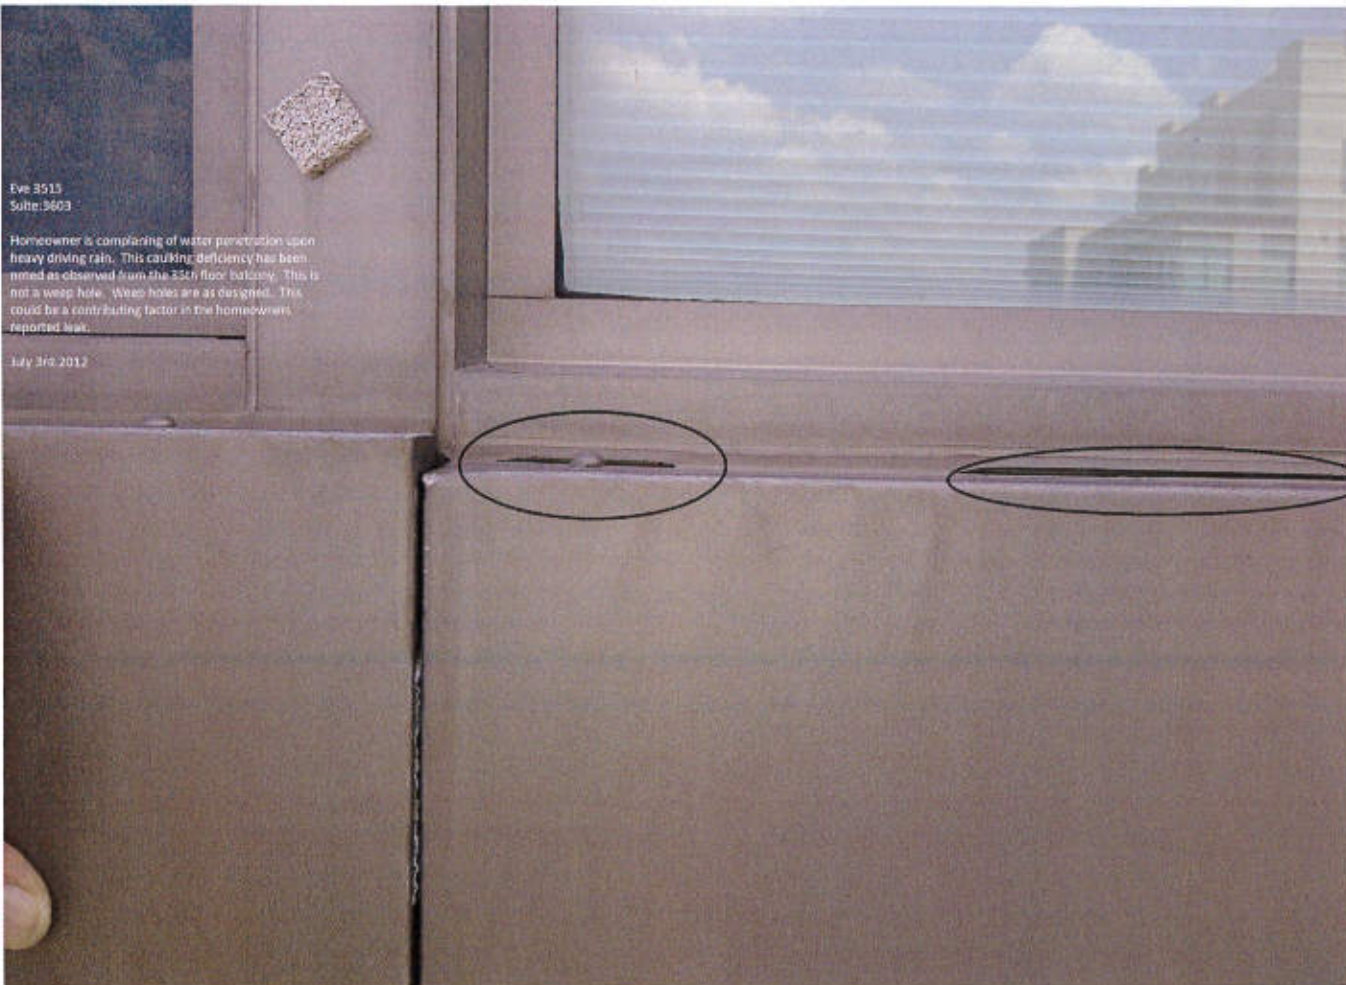
Eve 3513
Suite:3603

Homeowner is complaining of water penetration upon heavy driving rain. This caulking deficiency has been noted as observed from the 35th floor balcony. This is not a weep hole. Weep holes are as designed. This could be a contributing factor in the homeowners reported leak.

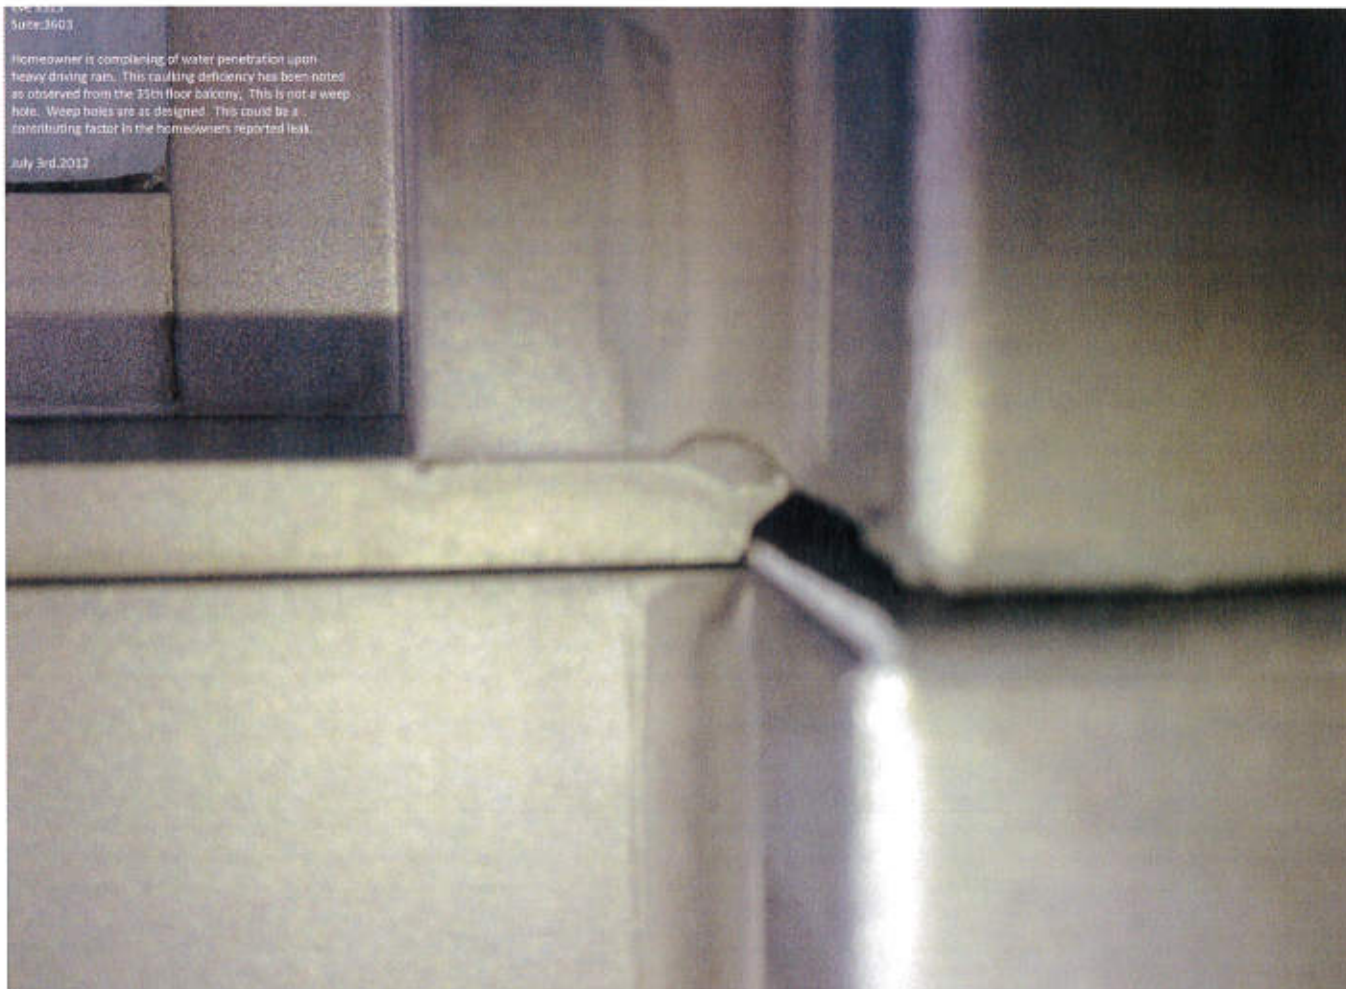
Eve 3513
Suite:3603

Homeowner is complaining of water penetration upon heavy driving rain. This caulking deficiency has been noted as observed from the 35th floor balcony. This is not a weep hole. Weep holes are as designed. This could be a contributing factor in the homeowners reported leak.

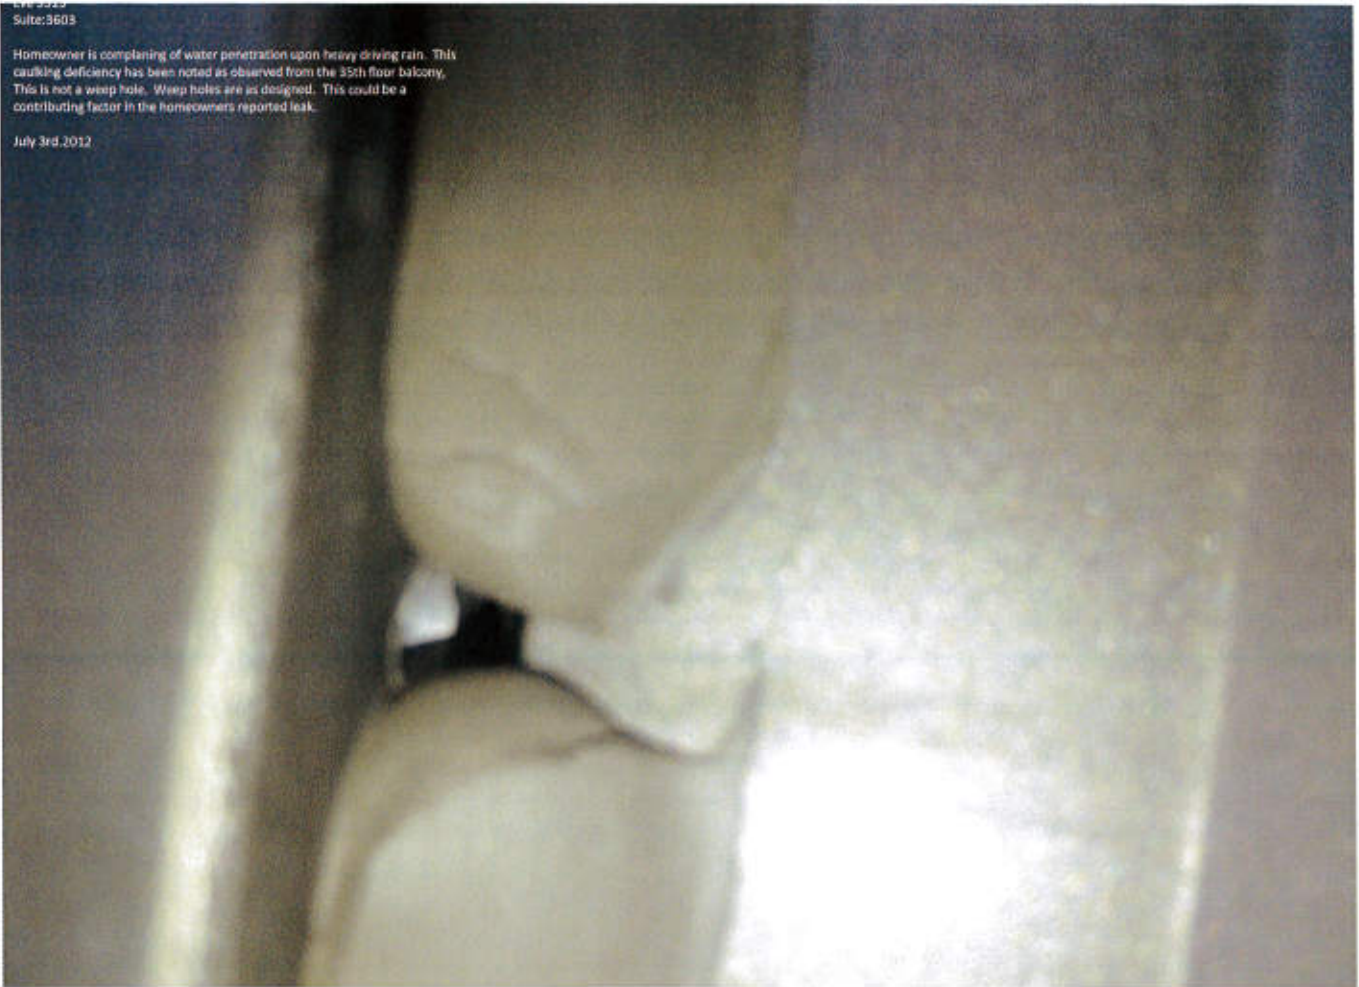
File:3513
Suite:3603

Homeowner is complaining of water penetration upon heavy driving rain. This caulking deficiency has been noted as observed from the 35th floor balcony. This is not a weep hole. Weep holes are as designed. This could be a contributing factor in the homeowners reported leak.

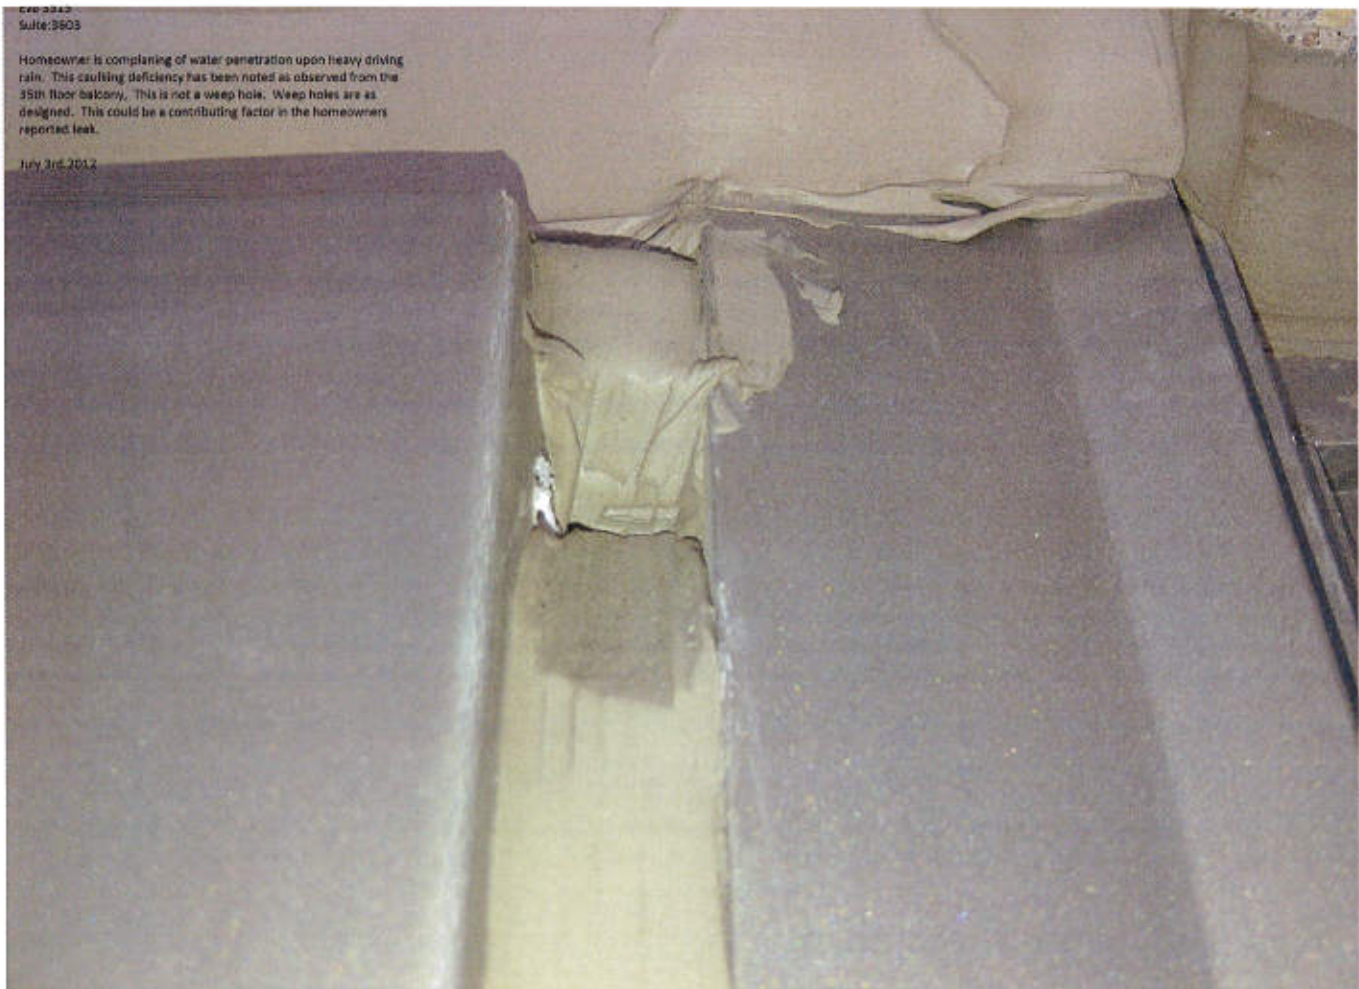
File:3513
Suite:3603

Homeowner is complaining of water penetration upon heavy driving rain. This caulking deficiency has been noted as observed from the 35th floor balcony. This is not a weep hole. Weep holes are as designed. This could be a contributing factor in the homeowners reported leak.

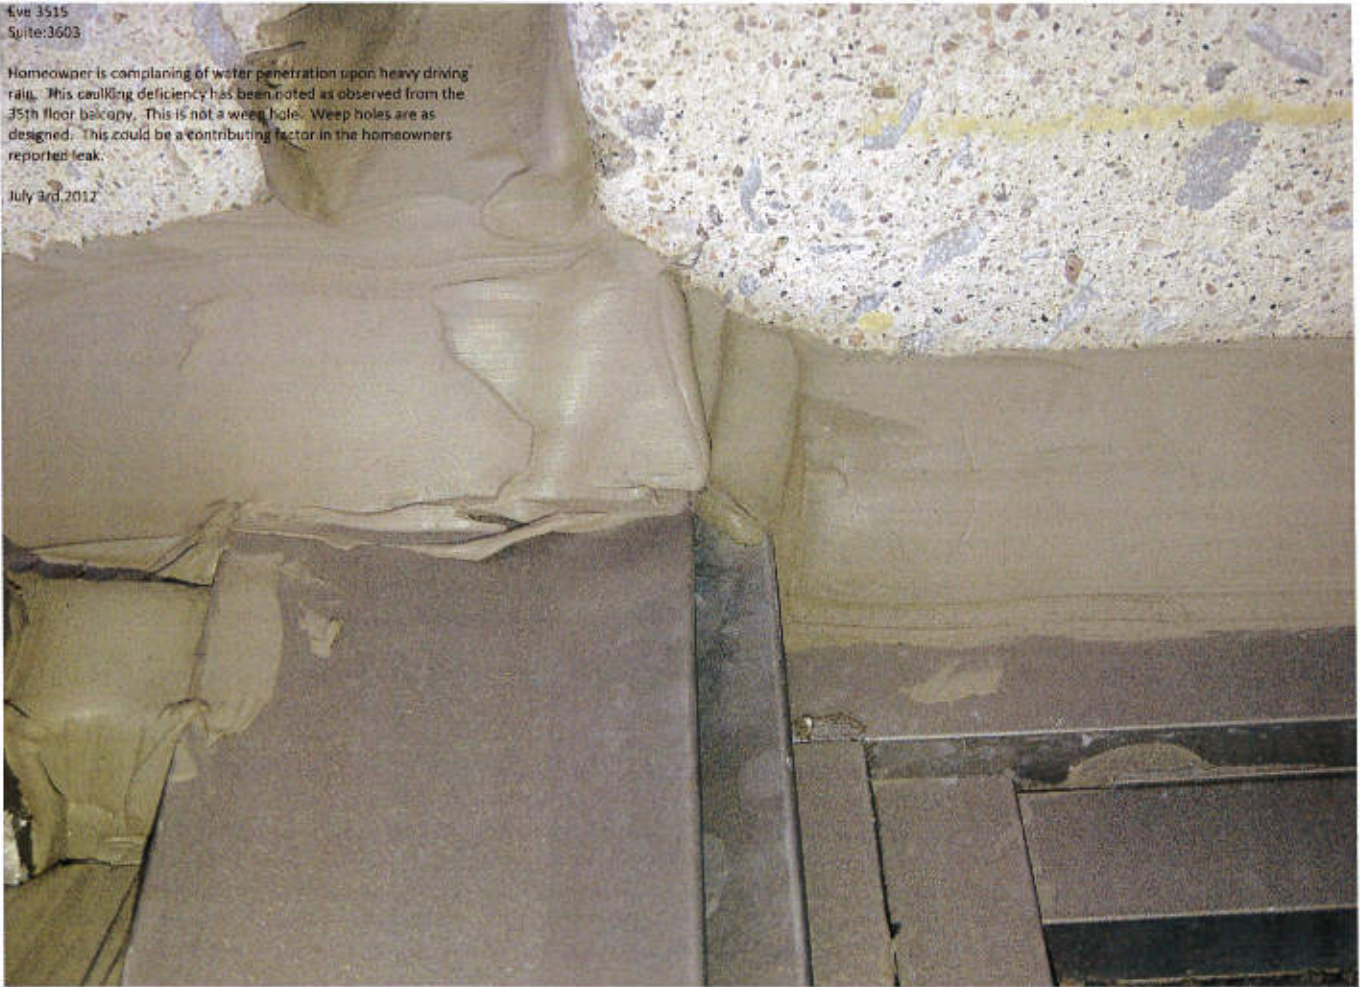
Eve 3515
Suite:3603

Homeowner is complaining of water penetration upon heavy driving rain. This caulking deficiency has been noted as observed from the 35th floor balcony. This is not a weep hole. Weep holes are as designed. This could be a contributing factor in the homeowners reported leak.

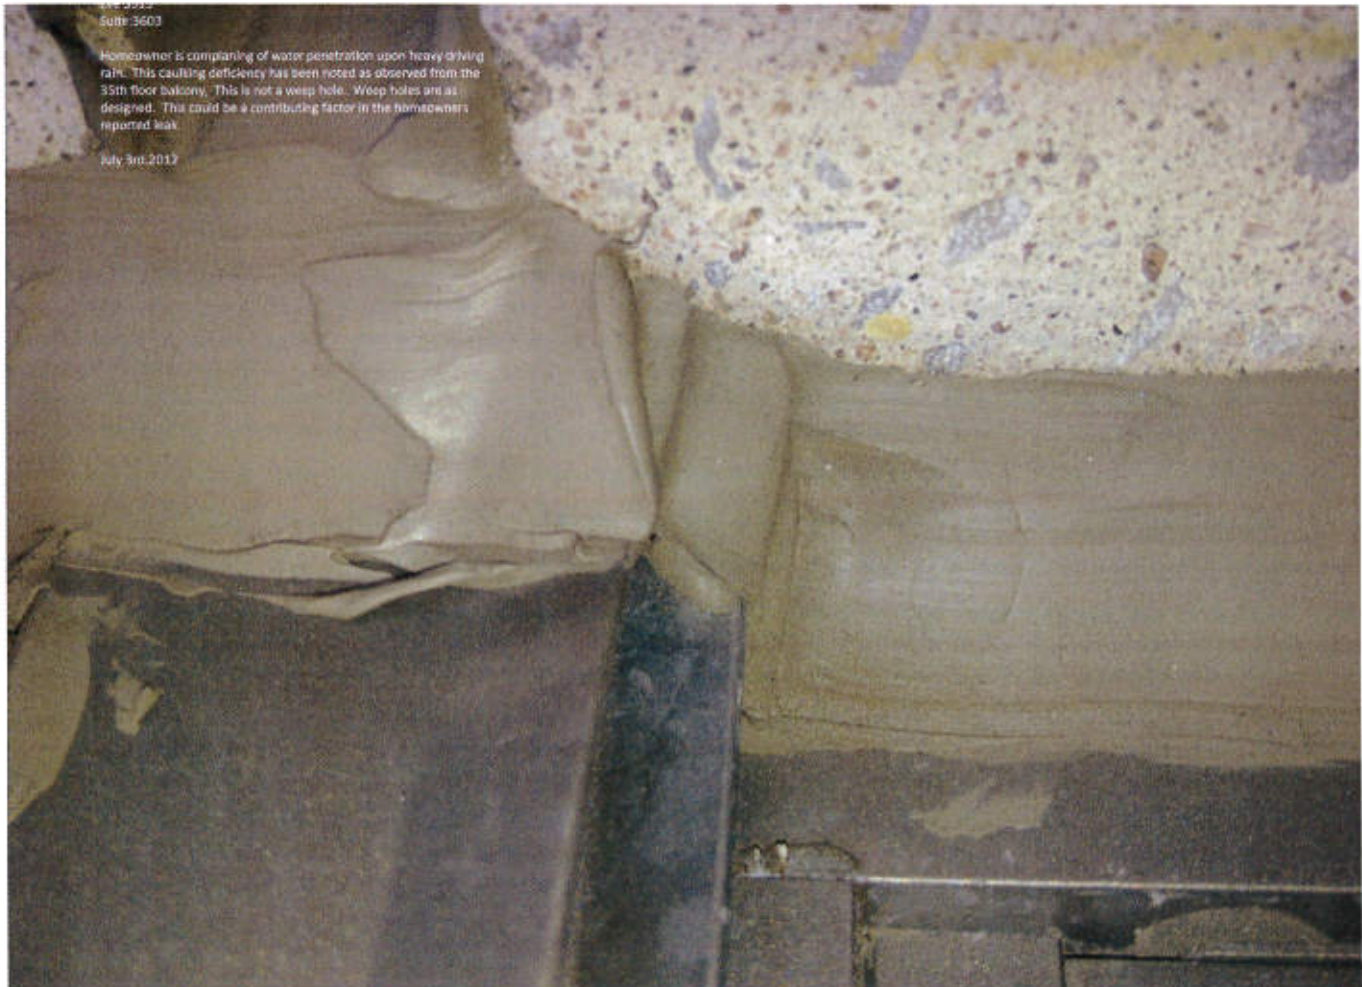
Eve 3515
Suite: 3603

Homeowner is complaining of water penetration upon heavy driving rain. This caulking deficiency has been noted as observed from the 35th floor balcony. This is not a weep hole. Weep holes are as designed. This could be a contributing factor in the homeowners reported leak.

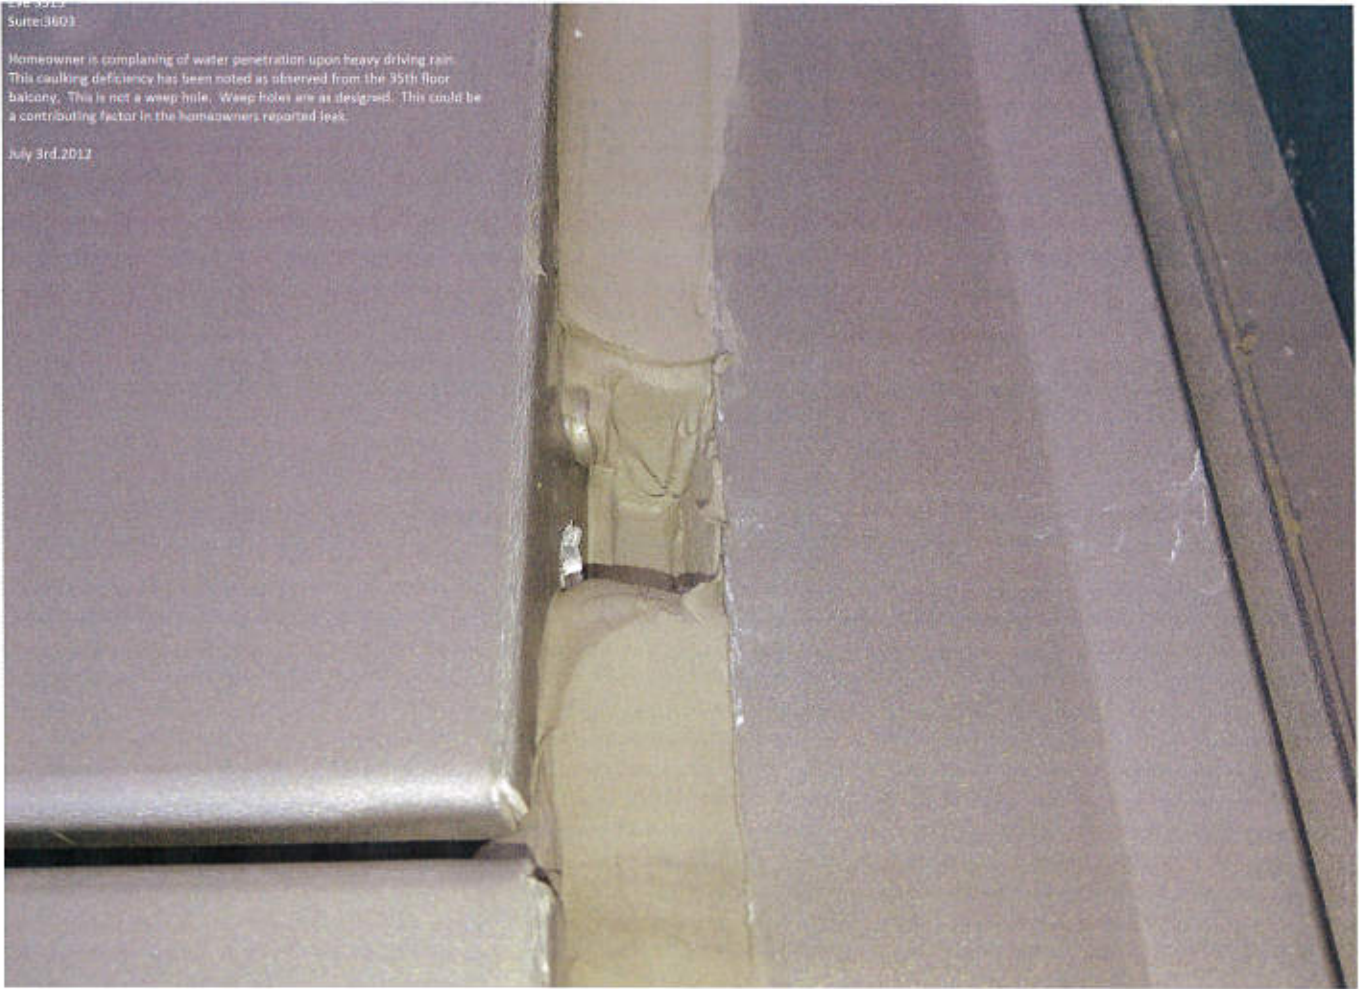
File 3311
Suite 3603

Homeowner is complaining of water penetration upon heavy driving rain. This caulking deficiency has been noted as observed from the 35th floor balcony. This is not a weep hole. Weep holes are as designed. This could be a contributing factor in the homeowners reported leak.

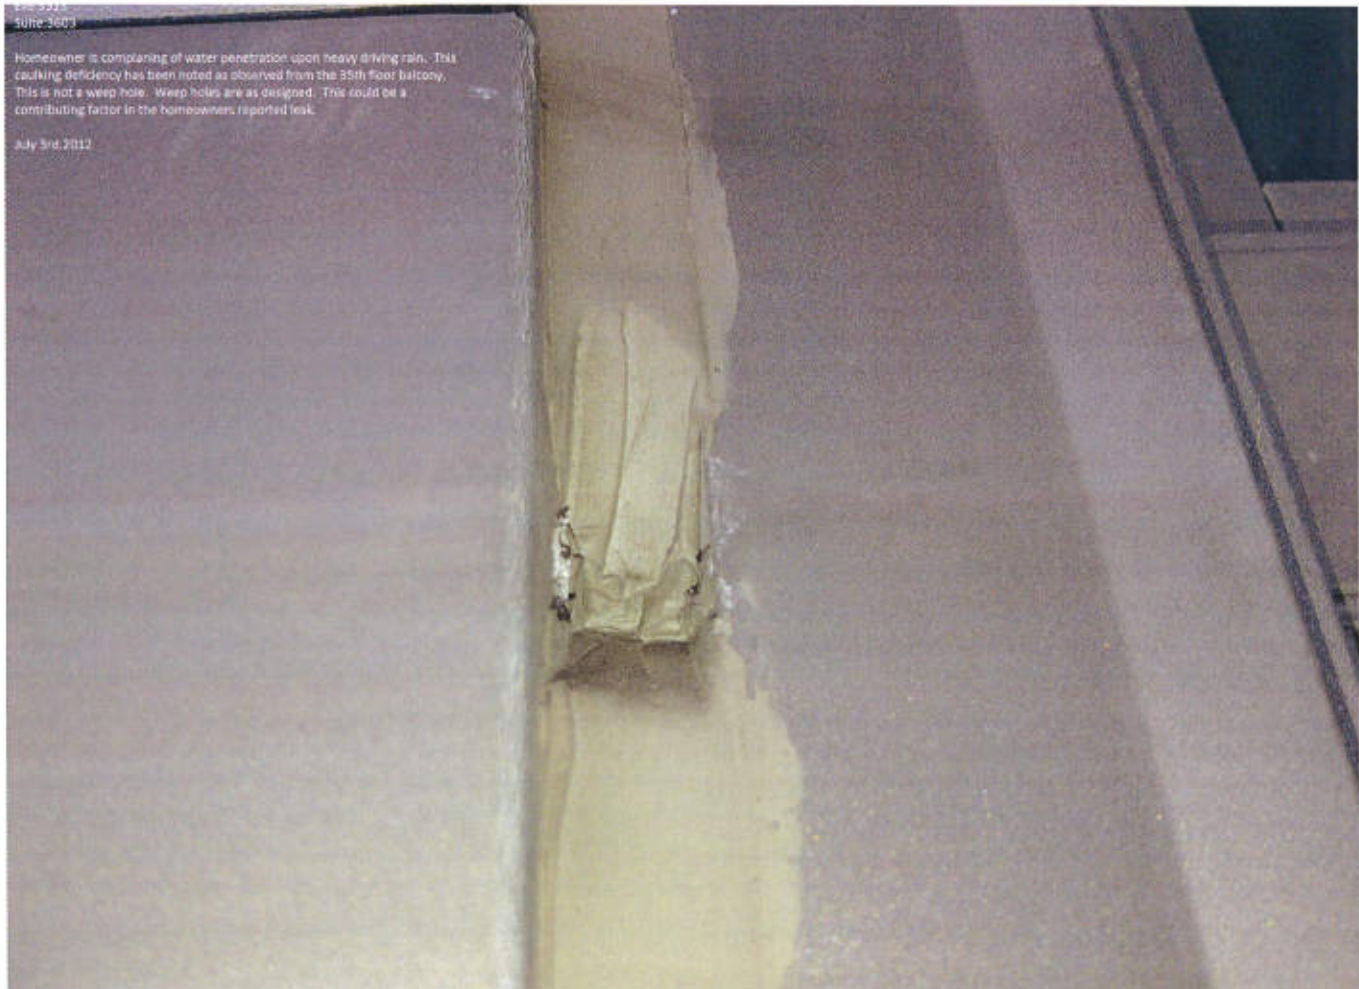
File 3311
Suite 3603

Homeowner is complaining of water penetration upon heavy driving rain. This caulking deficiency has been noted as observed from the 35th floor balcony. This is not a weep hole. Weep holes are as designed. This could be a contributing factor in the homeowners reported leak.
