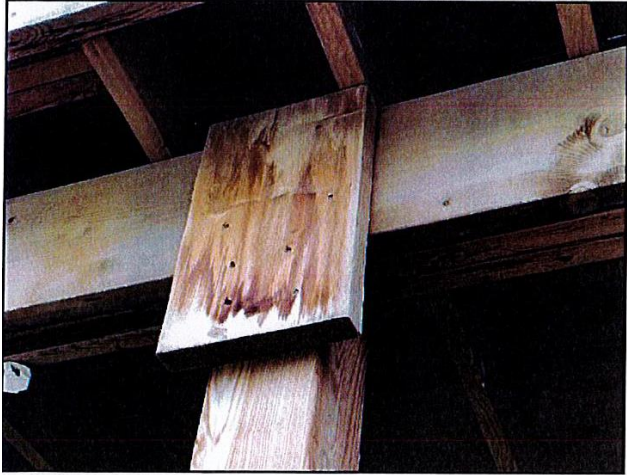
15. *Inadequate lateral support*

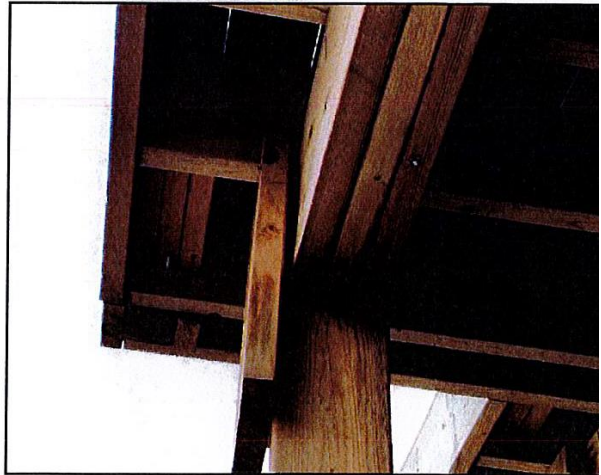
16. *Inadequate lateral support*

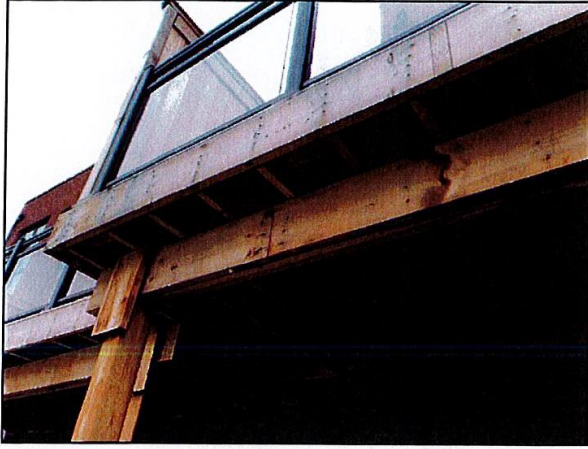
13. *Improperly-located splice*

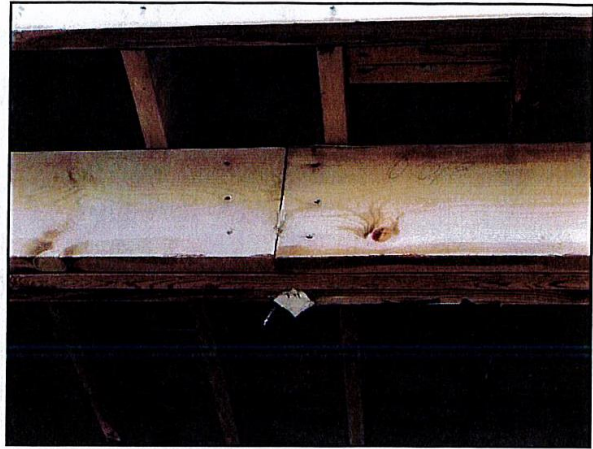
14. *Improperly-located splice*
