MEDI GROUP

WO Number : **W-084203**

Project : **ZANCOR-BROOKLIN TOWNS-3-21**

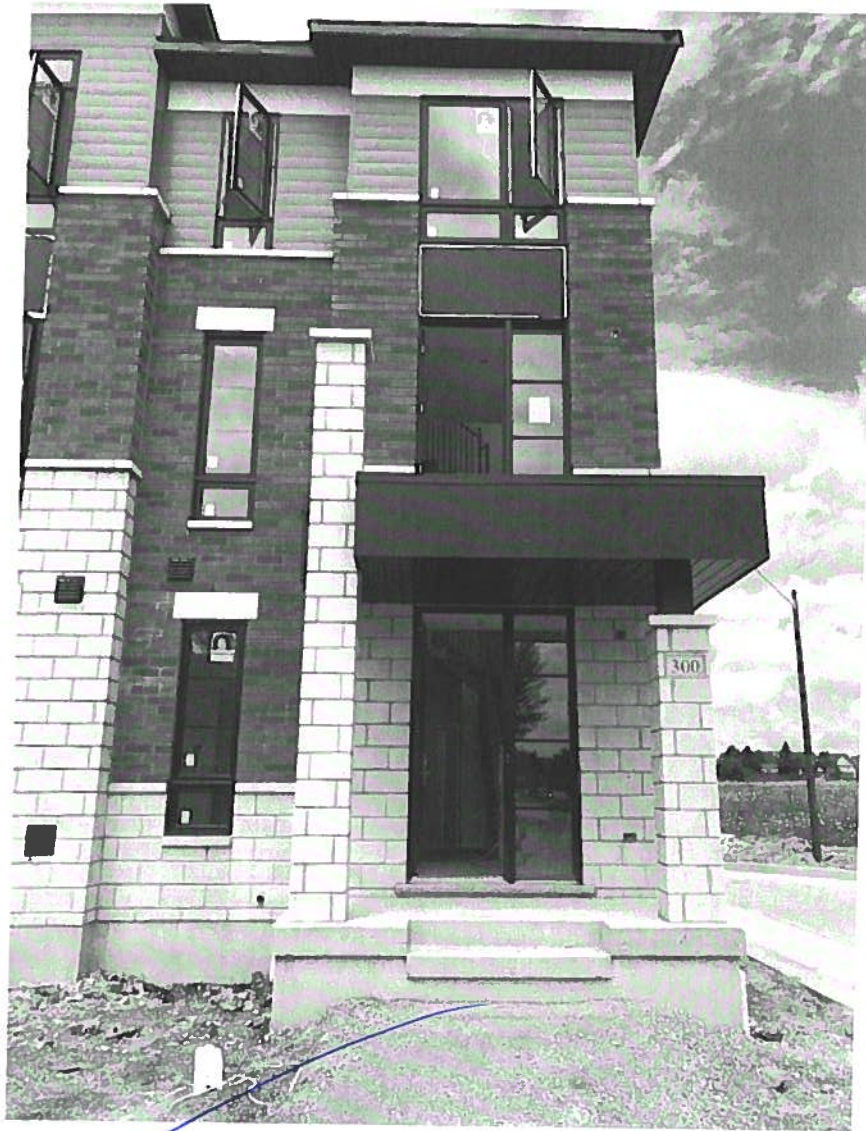
Blk#9 Unit#52 front column remove 1 course of stone:

INIT	Item	Work Description	PO	Builder Ref #
<input checked="" type="checkbox"/>	1	ADD MORTAR UNDER STEEL I-BEAM AT L/S		ALLAUG0922
<input checked="" type="checkbox"/>	2	FRONT COLUMN REMOVE 1 COURSE OF STONE - SEE PHOTO		S-065541
				08M101541
				S-065545
