Zancor Homes (Caledon) Ltd.  
Warranty Services  
Phone: (905) 738-7010  
Fax: (905) 738-5948

Work Order

Caledon Club - Phase: 1 - Lot: Block 149 Unit 2

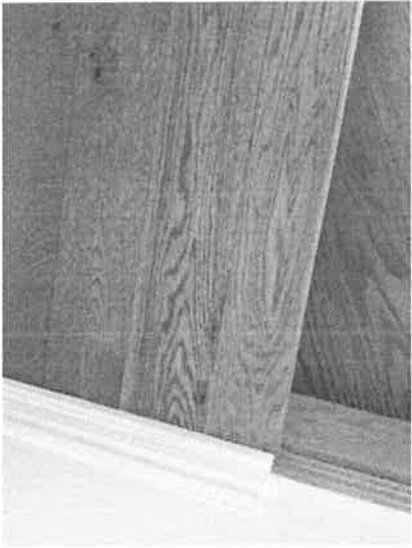
155007 - 1 - STAIRS~WRONG COLOUR  
COMPLETED AT NAIL HOLES AT FIRST LANDING  
AT STAIRS TO THIRD FLOOR

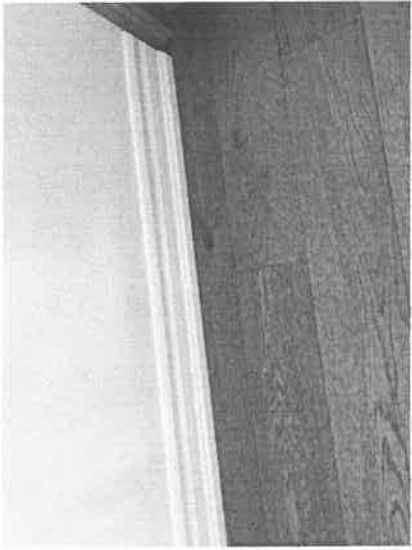
155007 - 2 - STAIRS~WRONG COLOUR  
COMPLETED AT NAIL HOLES AT FIRST LANDING  
AT STAIRS TO THIRD FLOOR

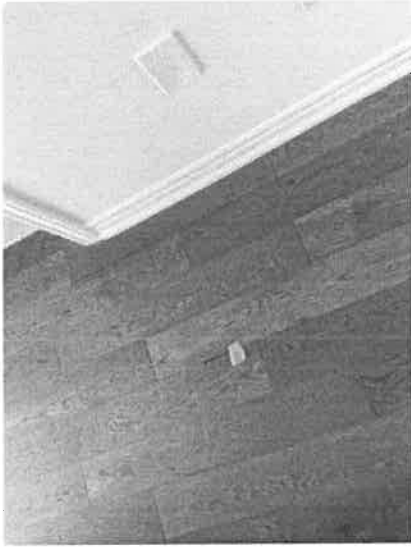
155012 - 1 - FLOORING~CHIP ON FIFTH  
HARDWOOD PLANK FROM CENTRAL VAC  
ROUGH IN 2) FILLER BETWEEN HARDWOOD  
PLANK AT 1ST PLANK FROM TRIM AT  
ENTRANCE TO MAIN BATH 3) CRACK AT  
HARDWOOD PLANK AT ENTRANCE TO  
BEDROOM 3 4) GAP BETWEEN HARDWOOD AND  
NOISING AT 3RD FLOOR

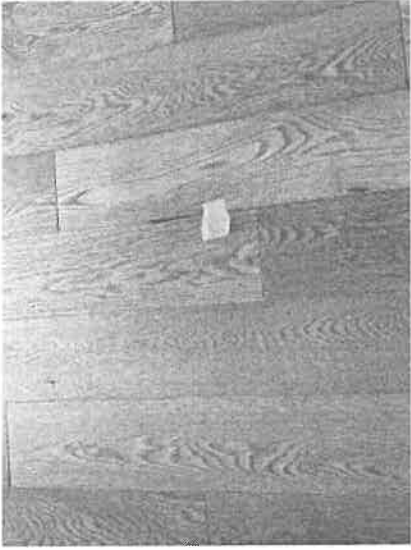
155012 - 2 - FLOORING~CHIP ON FIFTH  
HARDWOOD PLANK FROM CENTRAL VAC  
ROUGH IN 2) FILLER BETWEEN HARDWOOD  
PLANK AT 1ST PLANK FROM TRIM AT  
ENTRANCE TO MAIN BATH 3) CRACK AT  
HARDWOOD PLANK AT ENTRANCE TO  
BEDROOM 3 4) GAP BETWEEN HARDWOOD AND  
NOISING AT 3RD FLOOR

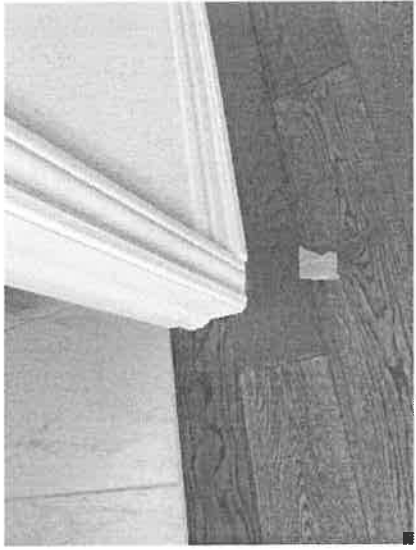
155012 - 3 - FLOORING~CHIP ON FIFTH  
HARDWOOD PLANK FROM CENTRAL VAC  
ROUGH IN 2) FILLER BETWEEN HARDWOOD  
PLANK AT 1ST PLANK FROM TRIM AT  
ENTRANCE TO MAIN BATH 3) CRACK AT  
HARDWOOD PLANK AT ENTRANCE TO  
BEDROOM 3 4) GAP BETWEEN HARDWOOD AND  
NOISING AT 3RD FLOOR

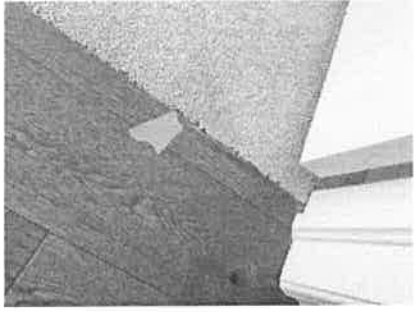
155012 - 4 - FLOORING~CHIP ON FIFTH  
HARDWOOD PLANK FROM CENTRAL VAC  
ROUGH IN 2) FILLER BETWEEN HARDWOOD  
PLANK AT 1ST PLANK FROM TRIM AT  
ENTRANCE TO MAIN BATH 3) CRACK AT  
HARDWOOD PLANK AT ENTRANCE TO  
BEDROOM 3 4) GAP BETWEEN HARDWOOD AND  
NOISING AT 3RD FLOOR

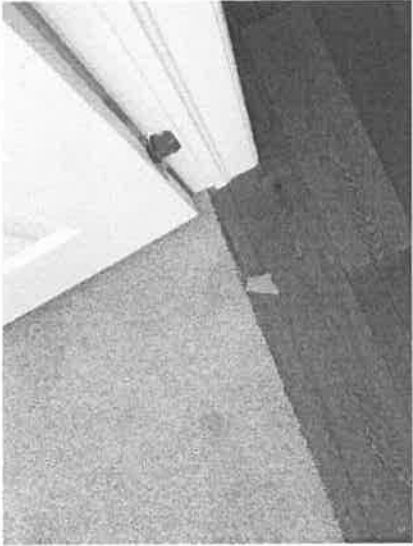
155012 - 5 - FLOORING~CHIP ON FIFTH  
HARDWOOD PLANK FROM CENTRAL VAC  
ROUGH IN 2) FILLER BETWEEN HARDWOOD  
PLANK AT 1ST PLANK FROM TRIM AT ENTRANCE  
TO MAIN BATH 3) CRACK AT HARDWOOD PLANK  
AT ENTRANCE TO BEDROOM 3 4) GAP BETWEEN  
HARDWOOD AND NOISING AT 3RD FLOOR

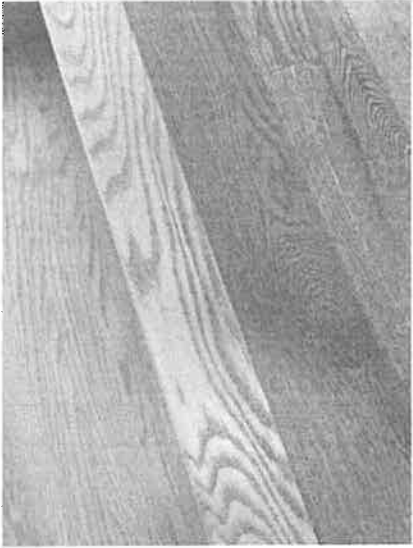
155012 - 6 - FLOORING~CHIP ON FIFTH  
HARDWOOD PLANK FROM CENTRAL VAC  
ROUGH IN 2) FILLER BETWEEN HARDWOOD  
PLANK AT 1ST PLANK FROM TRIM AT ENTRANCE  
TO MAIN BATH 3) CRACK AT HARDWOOD PLANK  
AT ENTRANCE TO BEDROOM 3 4) GAP BETWEEN  
HARDWOOD AND NOISING AT 3RD FLOOR

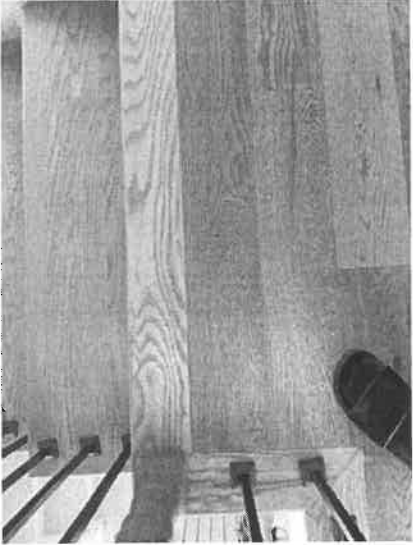
155012 - 7 - FLOORING~CHIP ON FIFTH  
HARDWOOD PLANK FROM CENTRAL VAC  
ROUGH IN 2) FILLER BETWEEN HARDWOOD  
PLANK AT 1ST PLANK FROM TRIM AT  
ENTRANCE TO MAIN BATH 3) CRACK AT  
HARDWOOD PLANK AT ENTRANCE TO  
BEDROOM 3 4) GAP BETWEEN HARDWOOD AND  
NOISING AT 3RD FLOOR

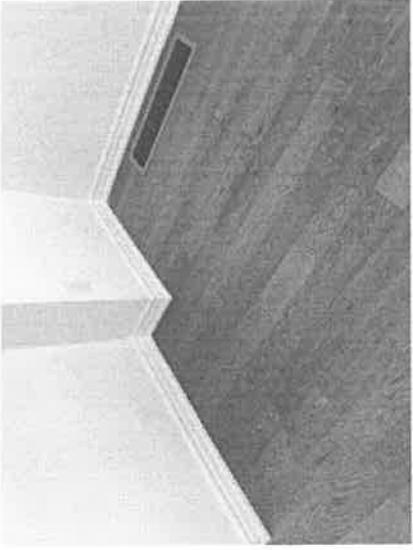
155013 - 1 - FLOORING~SCRATCH ON 10TH  
HARDWOOD PLANK FROM AIR RETURN ON  
FLOOR IN FRONT OF HRV UNIT 2)CHIP ON 19TH  
AND 26TH HARDWOOD PLANK INFRONT OF AIR  
RETURN 3)SCRATCH ON 1ST HARDWOOD  
PLANK FROM RIGHT SIDE OF FIRE PLACE  
CORNER WALL INFRONT OF INTERNET ROUGH  
IN 4)CHIP ON 4RTH HARDWOOD PLANK INFRONT  
OF FIRE PLACE 5) INSPECT FILLER USED AT  
HARDWOOD INFRONT OF WINDOW

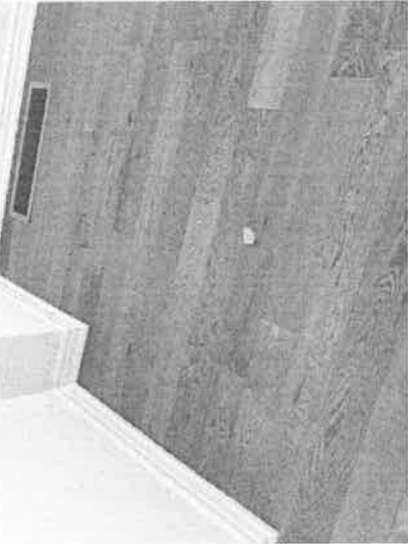
155013 - 2 - FLOORING~SCRATCH ON 10TH  
HARDWOOD PLANK FROM AIR RETURN ON  
FLOOR IN FRONT OF HRV UNIT 2)CHIP ON 19TH  
AND 26TH HARDWOOD PLANK INFRONT OF AIR  
RETURN 3)SCRATCH ON 1ST HARDWOOD  
PLANK FROM RIGHT SIDE OF FIRE PLACE

CORNER WALL INFRONT OF INTERNET ROUGH  
IN 4)CHIP ON 4RTH HARDWOOD PLANK  
INFRONT OF FIRE PLACE 5) INSPECT FILLER  
USED AT HARDWOOD INFRONT OF WINDOW

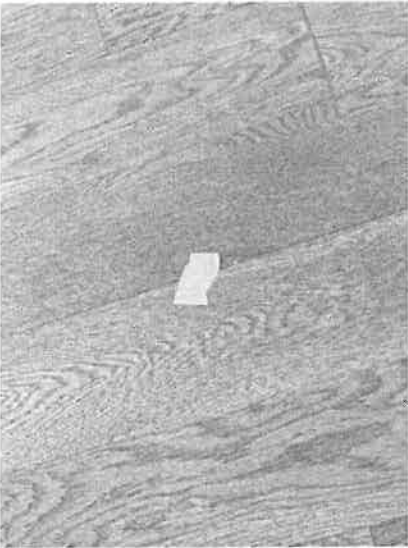
155013 - 3 - FLOORING~SCRATCH ON 10TH  
HARDWOOD PLANK FROM AIR RETURN ON  
FLOOR IN FRONT OF HRV UNIT 2)CHIP ON 19TH  
AND 26TH HARDWOOD PLANK INFRONT OF AIR  
RETURN 3)SCRATCH ON 1ST HARDWOOD  
PLANK FROM RIGHT SIDE OF FIRE PLACE

CORNER WALL INFRONT OF INTERNET ROUGH  
IN 4)CHIP ON 4RTH HARDWOOD PLANK  
INFRONT OF FIRE PLACE 5) INSPECT FILLER  
USED AT HARDWOOD INFRONT OF WINDOW

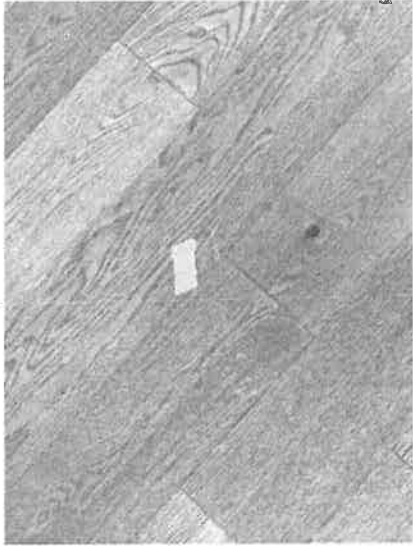
155013 - 4 - FLOORING~SCRATCH ON 10TH  
HARDWOOD PLANK FROM AIR RETURN ON  
FLOOR IN FRONT OF HRV UNIT 2)CHIP ON 19TH  
AND 26TH HARDWOOD PLANK INFRONT OF AIR  
RETURN 3)SCRATCH ON 1ST HARDWOOD PLANK  
FROM RIGHT SIDE OF FIRE PLACE CORNER  
WALL INFRONT OF INTERNET ROUGH IN 4)CHIP  
ON 4RTH HARDWOOD PLANK INFRONT OF FIRE  
PLACE 5) INSPECT FILLER USED AT HARDWOOD  
INFRONT OF WINDOW

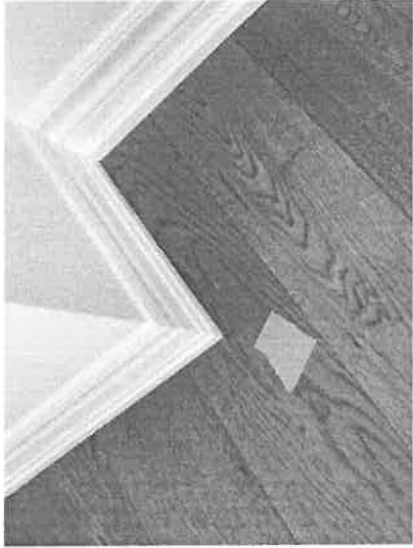
155013 - 5 - FLOORING~SCRATCH ON 10TH  
HARDWOOD PLANK FROM AIR RETURN ON  
FLOOR IN FRONT OF HRV UNIT 2)CHIP ON 19TH  
AND 26TH HARDWOOD PLANK INFRONT OF AIR  
RETURN 3)SCRATCH ON 1ST HARDWOOD PLANK  
FROM RIGHT SIDE OF FIRE PLACE CORNER  
WALL INFRONT OF INTERNET ROUGH IN 4)CHIP  
ON 4RTH HARDWOOD PLANK INFRONT OF FIRE  
PLACE 5) INSPECT FILLER USED AT HARDWOOD  
INFRONT OF WINDOW

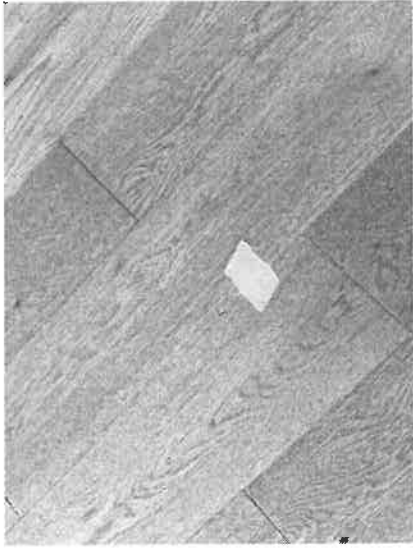
155013 - 6 - FLOORING~SCRATCH ON 10TH  
HARDWOOD PLANK FROM AIR RETURN ON  
FLOOR IN FRONT OF HRV UNIT 2)CHIP ON 19TH  
AND 26TH HARDWOOD PLANK INFRONT OF AIR  
RETURN 3)SCRATCH ON 1ST HARDWOOD  
PLANK FROM RIGHT SIDE OF FIRE PLACE  
CORNER WALL INFRONT OF INTERNET ROUGH  
IN 4)CHIP ON 4RTH HARDWOOD PLANK INFRONT  
OF FIRE PLACE 5) INSPECT FILLER USED AT  
HARDWOOD INFRONT OF WINDOW

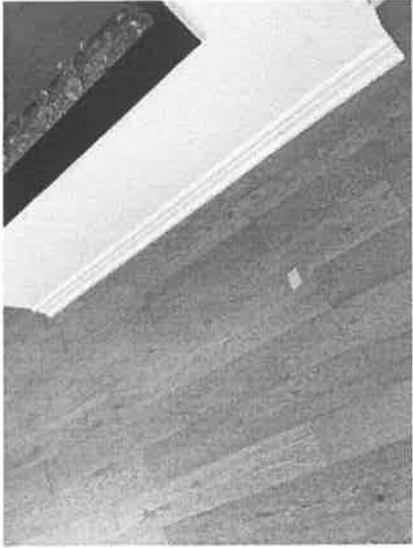
155013 - 7 - FLOORING~SCRATCH ON 10TH  
HARDWOOD PLANK FROM AIR RETURN ON  
FLOOR IN FRONT OF HRV UNIT 2)CHIP ON 19TH  
AND 26TH HARDWOOD PLANK INFRONT OF AIR  
RETURN 3)SCRATCH ON 1ST HARDWOOD  
PLANK FROM RIGHT SIDE OF FIRE PLACE  
CORNER WALL INFRONT OF INTERNET ROUGH  
IN 4)CHIP ON 4RTH HARDWOOD PLANK INFRONT  
OF FIRE PLACE 5) INSPECT FILLER USED AT  
HARDWOOD INFRONT OF WINDOW

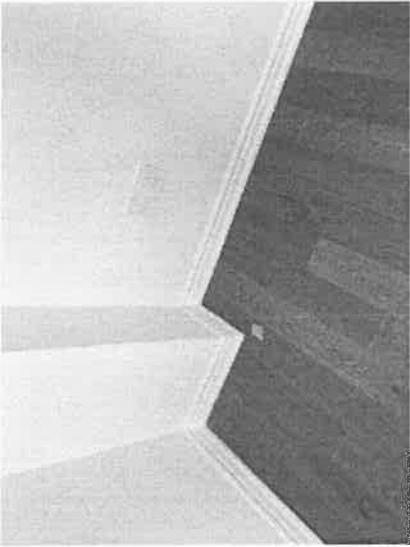
155013 - 8 - FLOORING~SCRATCH ON 10TH  
HARDWOOD PLANK FROM AIR RETURN ON  
FLOOR IN FRONT OF HRV UNIT 2)CHIP ON 19TH

AND 26TH HARDWOOD PLANK INFRONT OF AIR  
RETURN 3)SCRATCH ON 1ST HARDWOOD  
PLANK FROM RIGHT SIDE OF FIRE PLACE  
CORNER WALL INFRONT OF INTERNET ROUGH  
IN 4)CHIP ON 4RTH HARDWOOD PLANK  
INFRONT OF FIRE PLACE 5) INSPECT FILLER  
USED AT HARDWOOD INFRONT OF WINDOW

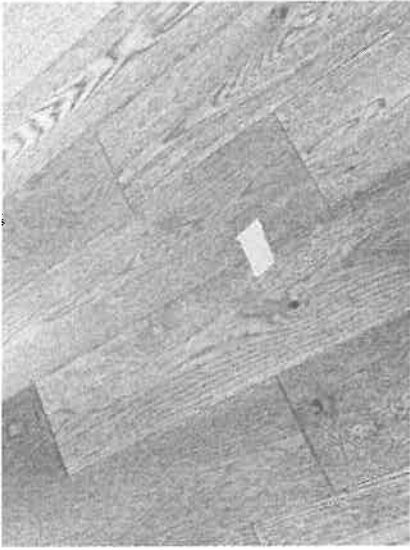
155013 - 9 - FLOORING~SCRATCH ON 10TH  
HARDWOOD PLANK FROM AIR RETURN ON  
FLOOR IN FRONT OF HRV UNIT 2)CHIP ON 19TH

AND 26TH HARDWOOD PLANK INFRONT OF AIR  
RETURN 3)SCRATCH ON 1ST HARDWOOD  
PLANK FROM RIGHT SIDE OF FIRE PLACE  
CORNER WALL INFRONT OF INTERNET ROUGH  
IN 4)CHIP ON 4RTH HARDWOOD PLANK  
INFRONT OF FIRE PLACE 5) INSPECT FILLER  
USED AT HARDWOOD INFRONT OF WINDOW

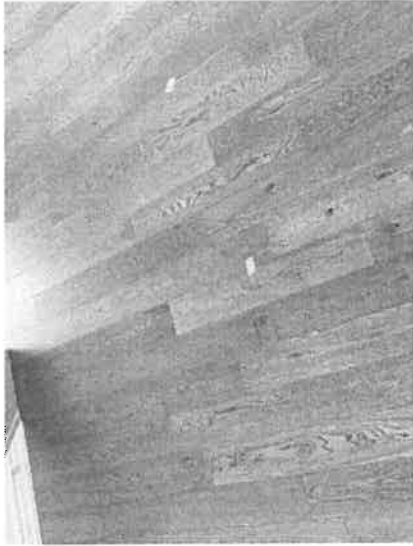
155013 - 10 - FLOORING~SCRATCH ON 10TH  
HARDWOOD PLANK FROM AIR RETURN ON  
FLOOR IN FRONT OF HRV UNIT 2)CHIP ON 19TH  
AND 26TH HARDWOOD PLANK INFRONT OF AIR  
RETURN 3)SCRATCH ON 1ST HARDWOOD PLANK  
FROM RIGHT SIDE OF FIRE PLACE CORNER  
WALL INFRONT OF INTERNET ROUGH IN 4)CHIP  
ON 4RTH HARDWOOD PLANK INFRONT OF FIRE  
PLACE 5) INSPECT FILLER USED AT HARDWOOD  
INFRONT OF WINDOW

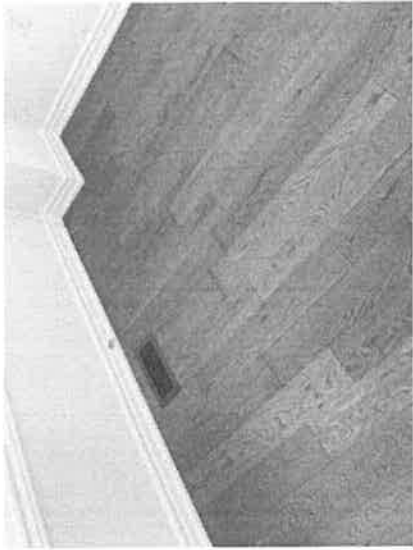
155013 - 11 - FLOORING~SCRATCH ON 10TH  
HARDWOOD PLANK FROM AIR RETURN ON  
FLOOR IN FRONT OF HRV UNIT 2)CHIP ON 19TH  
AND 26TH HARDWOOD PLANK INFRONT OF AIR  
RETURN 3)SCRATCH ON 1ST HARDWOOD PLANK  
FROM RIGHT SIDE OF FIRE PLACE CORNER  
WALL INFRONT OF INTERNET ROUGH IN 4)CHIP  
ON 4RTH HARDWOOD PLANK INFRONT OF FIRE  
PLACE 5) INSPECT FILLER USED AT HARDWOOD  
INFRONT OF WINDOW

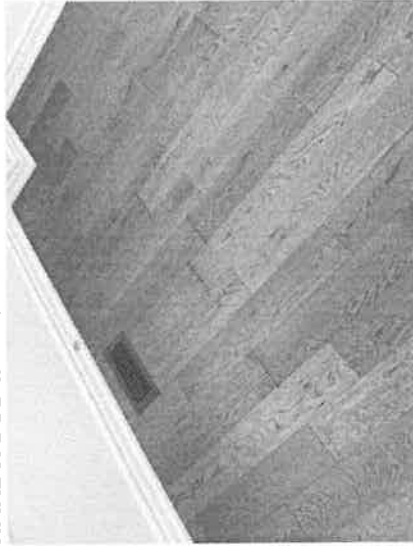
155013 - 12 - FLOORING~SCRATCH ON 10TH  
HARDWOOD PLANK FROM AIR RETURN ON  
FLOOR IN FRONT OF HRV UNIT 2)CHIP ON 19TH  
AND 26TH HARDWOOD PLANK INFRONT OF AIR  
RETURN 3)SCRATCH ON 1ST HARDWOOD  
PLANK FROM RIGHT SIDE OF FIRE PLACE  
CORNER WALL INFRONT OF INTERNET ROUGH  
IN 4)CHIP ON 4RTH HARDWOOD PLANK INFRONT  
OF FIRE PLACE 5) INSPECT FILLER USED AT  
HARDWOOD INFRONT OF WINDOW
