Project:

Zancor Homes (Caledon) Ltd.

145B / 1B

Inspection Date: Aug 11, 2023

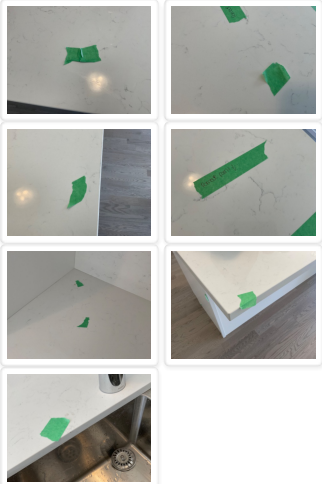
Deficiency:
SCRATCHES ON COUNTER TOP BEHIND SINK REMOVE GLUE REMOVE PAINT

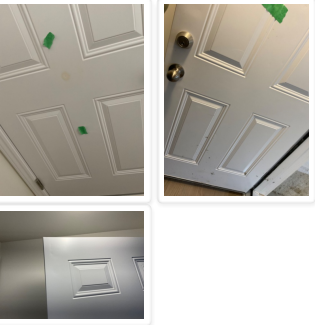
Deficiency:
DENTS ON GARAGE MAN DOOR BOTH SIDES
