Zancor Homes (Innisfil) Ltd.  
Warranty Services  
Phone: (905) 738-7010  
Fax: (905) 738-5948

Work Order

Location: Belle Aire Shores - Phase: 3 - Lot: 87W

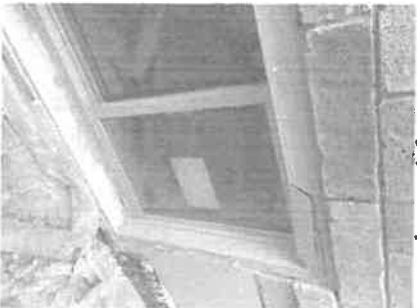
**166425 - 1 - 1 - trim piece at window damaged -  
noted at key pick up**
