**Zancor Homes (Wasaga) Ltd.**  
**Warranty Services**  
**Phone: (905) 738-7010**  
**Fax: (905) 738-5948**

**Work Order**

**Location:** Shoreline Point - Phase: 1 - Lot: 5

**Company:** Promark Aluminum LTD.

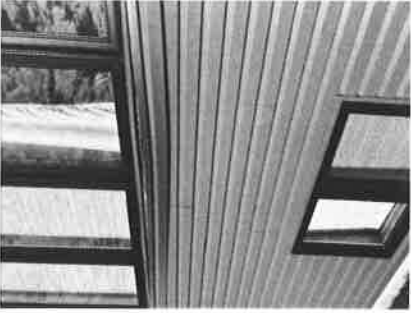
Screenshot\_20240422\_154423\_WhatsApp - .  
Secure siding below living room window at rear  
home

| DAI | Type | Issue | | Appt.<br>Date/Time | Notes |
|---|---|---|--|---|---|
| 175591 | Interval | Exterior- General-<br>Secure siding below<br>living room window at<br>rear home | | | |

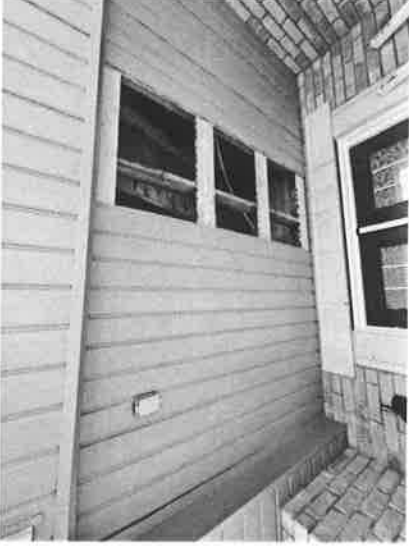
175350 - 1 - 20240415\_182639 - The metal fascia on the ceiling of the veranda at the front door had 4 pieces that had fallen off and one piece that was hanging there. Upon inspection, it appears that only one of those pieces had a screw in it and the rest were not installed with any fasteners. We were able to look at the other ones that had not yet fallen and only 1 of the remaining pieces had 1 faster a.d are destined to fall off. It seems like the roofing guys did not fasten the metal correctly

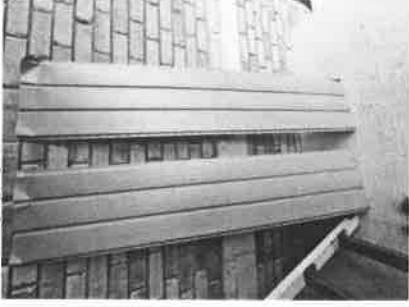
175350 - 2 - 20240415\_182647 - The metal fascia on the ceiling of the veranda at the front door had 4 pieces that had fallen off and one piece that was hanging there. Upon inspection, it appears that only one of those pieces had a screw in it and the rest were not installed with any fasteners. We were able to look at the other ones that had not yet fallen and only 1 of the remaining pieces had 1 faster a.d are destined to fall off. It seems like the roofing guys did not fasten the metal correctly

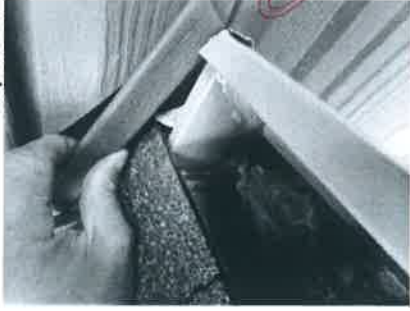
173869 - 1 - 2 - The siding right where they said itâ€™s leaking was cut short so they tried to fill it with a scrap piece. There is no diverter where the step flashingâ€™s begin and when I lift up on the J-trim Right at the trough you can see Tyvec and behind the siding. Any water running down our steps is going straight behind the siding. On a side note where our metal pan is, they have installed aluminum in 3 pieces and there is still wood exposed.. if snow accumulates in that area it can easily get behind that aluminum. If water does get behind their aluminum and siding on the front porch looking up at that section of concern there is visible wood exposed at the soffit.

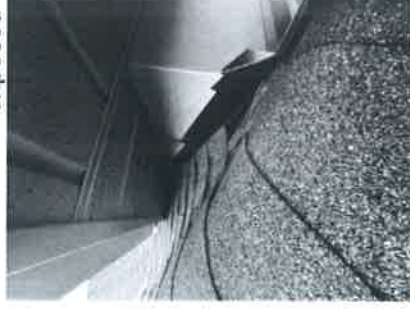
173869 - 2 - 3 - The siding right where they said itâ€™s leaking was cut short so they tried to fill it with a scrap piece. There is no diverter where the step flashingâ€™s begin and when I lift up on the J-trim Right at the trough you can see Tyvec and behind the siding. Any water running down our steps is going straight behind the siding. On a side note where our metal pan is, they have installed aluminum in 3 pieces and there is still wood exposed.. if snow accumulates in that area it can easily get behind that aluminum. If water does get behind their aluminum and siding on the front porch looking up at that section of concern there is visible wood exposed at the soffit.

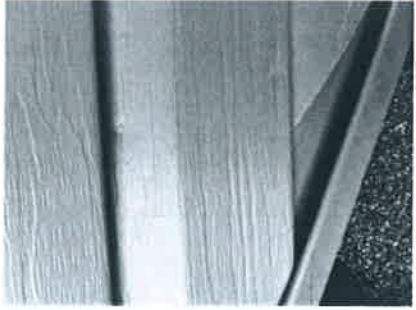
173869 - 4 - 5 - The siding right where they said itâ€™s leaking was cut short so they tried to fill it with a scrap piece. There is no diverter where the step flashingâ€™s begin and when I lift up on the J-trim Right at the trough you can see Tyvec and behind the siding. Any water running down our steps is going straight behind the siding. On a side note where our metal pan is, they have installed aluminum in 3 pieces and there is still wood exposed.. if snow accumulates in that area it can easily get behind that aluminum. If water does get behind their aluminum and siding on the front porch looking up at that section of concern there is visible wood exposed at the soffit.

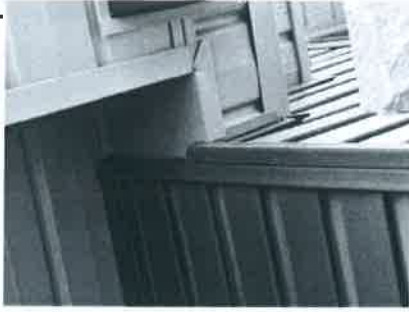
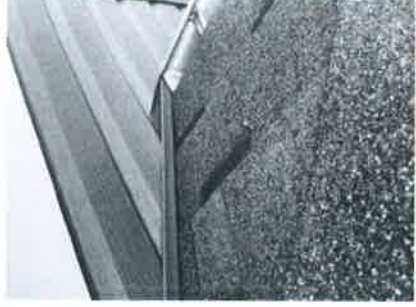
173869 - 5 - 1 - The siding right where they said itâ€™s leaking was cut short so they tried to fill it with a scrap piece. There is no diverter where the step flashingâ€™s begin and when I lift up on the J-trim Right at the trough you can see Tyvec and behind the siding. Any water running down our steps is going straight behind the siding. On a side note where our metal pan is, they have installed aluminum in 3 pieces and there is still wood exposed.. if snow accumulates in that area it can easily get behind that aluminum. If water does get behind their aluminum and siding on the front porch looking up at that section of concern there is visible wood exposed at the soffit.
